# Dynamic response of the rock mass where the orebody dip changes

Sanjay Singh

*South African National Institute of Rock Mechanics, Johannesburg, South Africa*

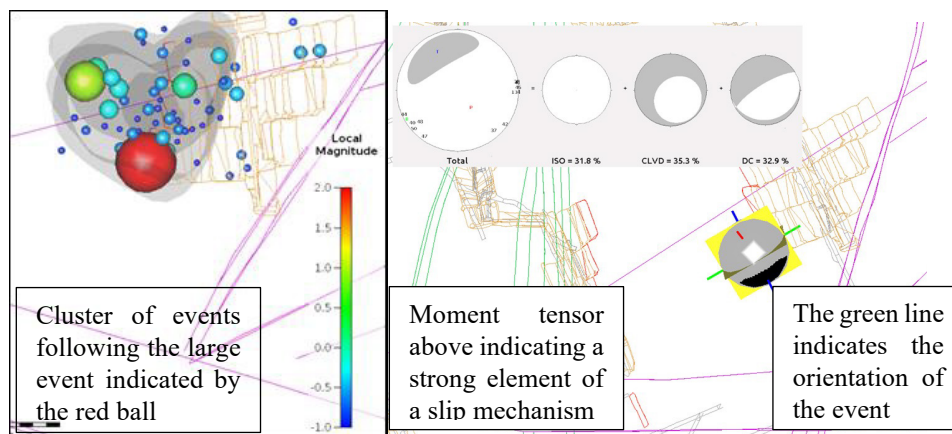
In the early hours of 21 October 2021, a magnitude 2.6 seismic event occurred on the reef horizon in close proximity to the skin of the working place. There was no seismic activity for the 24 hours preceding the major event. When scrutinizing the 6 largest events (Table 1),  $ML \geq 0.0$ , from 1 January 2021, it was noted that the workplace was dormant.

Figure 5. Seismic plot of the events and on the right is the seismic analysis.

The mechanism of the event shown in Figure 5, is based on the Seismologist report which indicated that the event had the following source mechanism:

*“The estimated source mechanism has an implosive ISO component (39.7%), a CLVD (Compensated linear vector dipole) component that indicates compression along a sub-vertical axis (29.8%), and a DC (Double couple) component that indicates normal slip on a ENE – WSW orientated plane (30.5%).” Reference 1.*

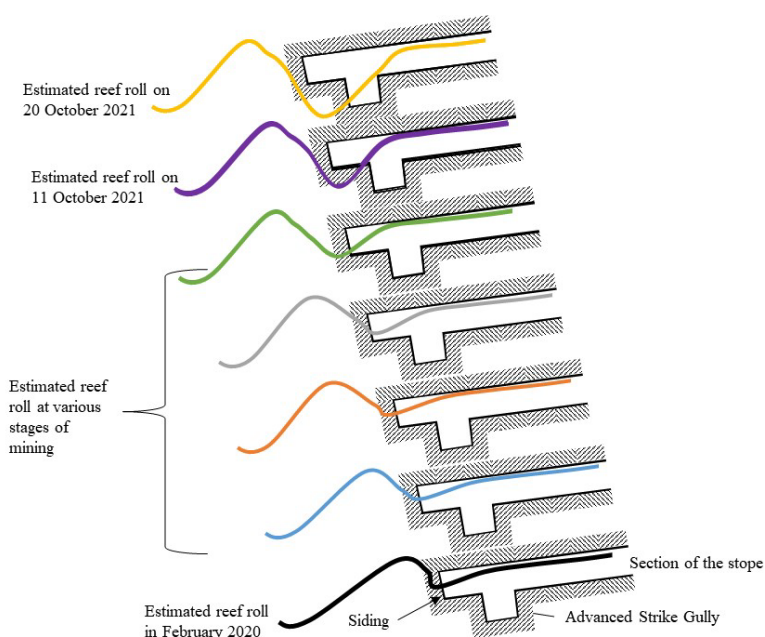
Figure 6. Section view illustrating the projected reef roll positions in relation to the advancing face.

Figure 6 is an illustration of the reef positions in relation to the ASG and siding. When the reef dipped into the footwall this was originally considered as a localized reef roll. The notion of the reef behaving similarly to a fault, was previously never considered. This theory was further tested using numerical modelling.

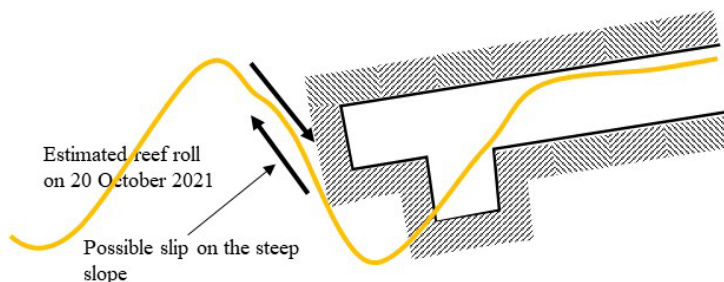
Figure 7. Section view of the stope depicting the slip mechanism.

Hanging and footwall rock types, having a high UCS results in squeezing the Ventersdorp Contact Reef, which is much softer, as depicted in Figure 7. Due to volumetric extraction in the adjacent raise lines, this caused loading on surrounding structures. This initiated slip on the structure, thus causing an event of 2.6ML. Following this event the rock mass, in its attempt to assume a state of equilibrium, initiated slip on the steep reef roll, inadvertently causing the abutment sidewall to behave in an explosive violent manner, which also caused ejection of the rock mass.

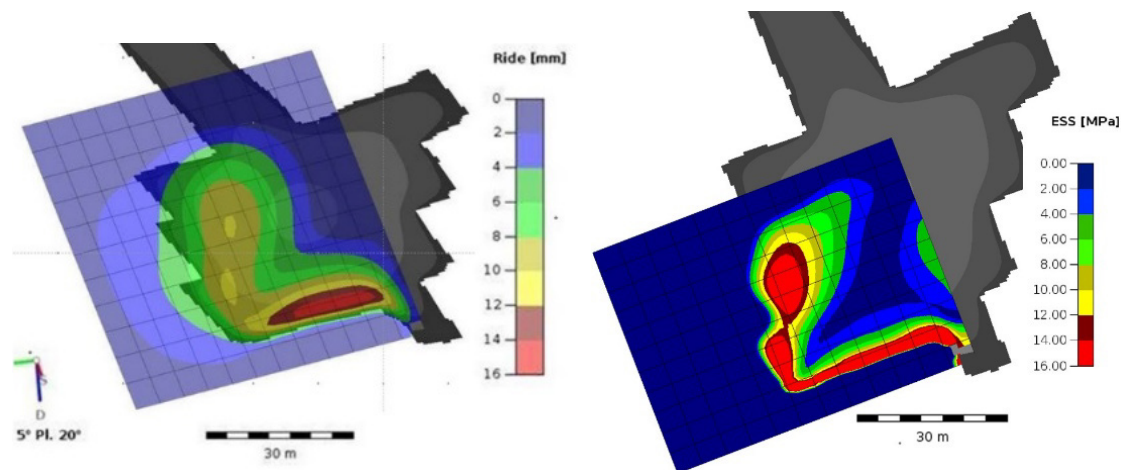
From the results the calculated ride on the "steep reef structure" parallel to the abutment dipping at about  $45^\circ$ , Figure 8, where the lobes extend from the abutment into the hanging wall of the panel. The corresponding potency approximates to  $50 \text{ m}^3$ , being consistent with the DC/shear component of the estimated source mechanism. The associated Excess Shear Stress (ESS) 14-16MPa (Figure 9).

Figure 8. Numerical modeling of ride on the steep reef roll. Figure 9. Numerical modelling depicting ESS.

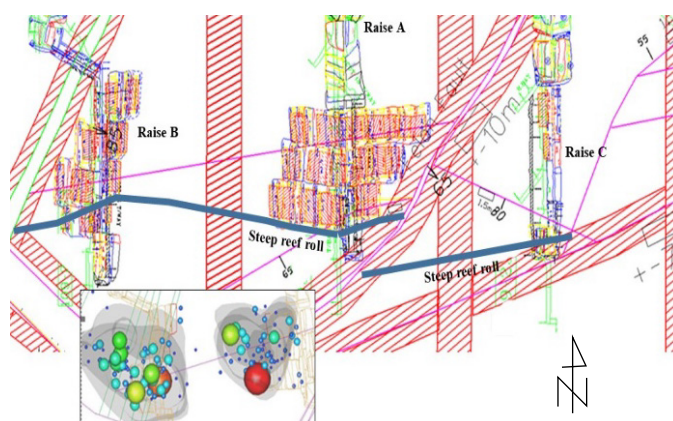
Given this newly acquired knowledge, that the steep reef roll are able to initiate its own slip mechanism, which further correlates with the results from the moment tensor analysis, prompting the scope of the study to be expanded to the adjacent raise lines to justify and confirm this new theory. The raise lines, located 200m to the east and west, were visited to identify similarities. (Figure 10)

- Raise B - Two panels to the east were off reef and in the 3<sup>rd</sup> panel the steep reef roll was evident. This is consistent with the location, trend and intensity of the seismic events.
- Raise C - The steep reef roll was intersected in the bottom-most panel to the west.

A correlation was drawn between the 3 raise lines and the steep reef roll which could be extrapolated between the raise lines. This was also confirmed during the underground observations.

Figure 10. Plan indicating adjacent raise lines and seismic plot insert. Raise A is where the incident occurred.

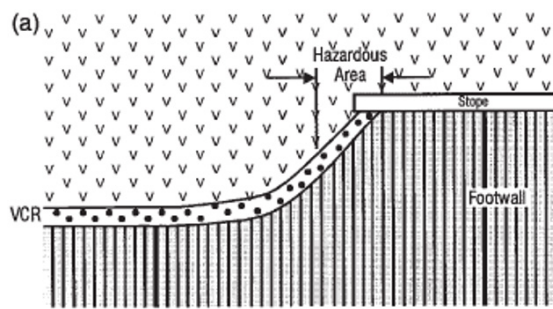
Figure 11. Section view of the steep reef.

This theory was first tested by *Roberts & Schweitzer*, May 1999, where it was identified that on the VCR where the reef goes from a terrace to a slope, an inflection point is created, which proved to be hazardous (Figure 11). Further research by the same literaries revealed that there is a correlation between the location of the slope / terrace and the rock burst related incidents (Figure 12).

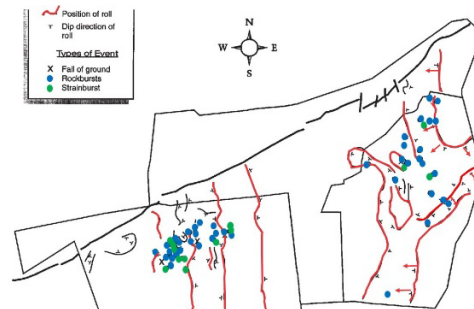
Figure 12. Plan with slopes plotted with the incidents.
