Structural mechanisms contributing to large-scale hangingwall instabilities on the UG2 reef horizon

Aletta G. Hartzenberg
SRK Consulting, Vancouver, Canada

Daniel Francois Malan
University of Pretoria, Pretoria, South Africa

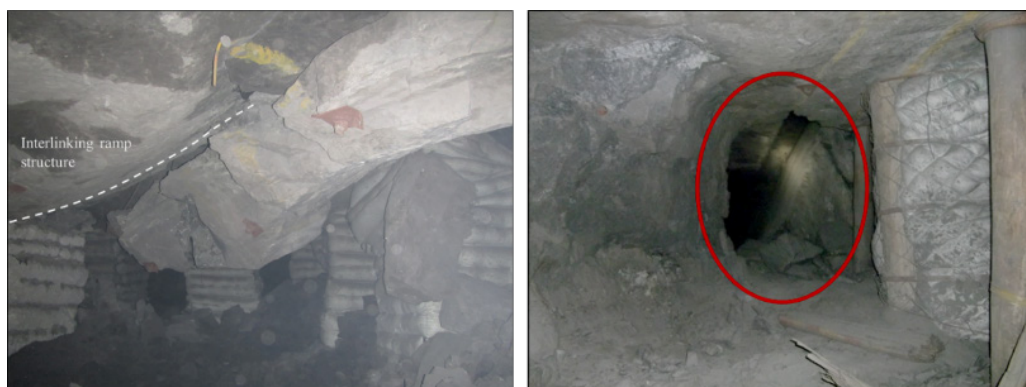
Figure 2. Left: Unstable hangingwall conditions in an underground stope panel where a low-angle ramp structure is present. The only support on the edge of this brow was in-stope rock bolt support and cementitious grout packs. Right: Panel instability shown at the red ellipse. Large-scale movement along a regional large-scale WNW-ESE trending fault structure caused a panel collapse.

On many operations, mining layouts and support designs are inherited from best practices in industry or to accommodate a specific extraction method. Adverse rock mass conditions are frequently not identified by mining personnel and the consequence of mining in these conditions is only realized once significant instabilities have occurred (Figure 2 and Figure 3).

The regional structures are continuous along multiple lithological units that cut deep into the HW of excavations, beyond the local support capacity. The strike, dip and continuation length of these structures should be considered in the mining layout. The low-angle ramp structures are usually difficult to identify and only visible once wedge failure had occurred along these structures (Figure 2). Therefore, the mining direction, approaching structures from the stable side, should be taken into consideration during production planning, based on the findings from underground geotechnical mapping and using the GPR.

Figure 6. Remedial strategies where regional and secondary geologic structures are present.

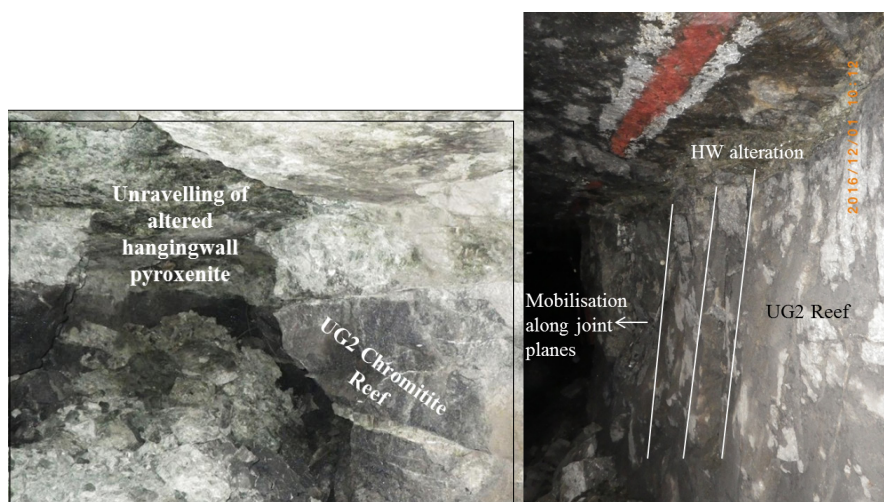
Figure 3. Left: Weak clay-like layer (alteration) zone exposed directly above the UG2 Reef, causing unravelling between installed support units. Right: Alteration along the top UG2 Reef contact causing mobilization along the joint planes. This led to pillar collapse.

The alteration zones are typically not detected by the exploration and underground drilling. After the exposure of these zones in an active section of an underground mine, it was noted that these zones can be present in the footwall (FW), HW (directly above the UG2 Reef) or higher up in the hangingwall (based on falls of ground that occurred). It also varies in thickness from a few centimeters to up to 1 m and undulates on strike and dip. Spatial variation along the dip and strike of the ore body and location in the HW should be considered. It was only during the underground development of excavations that exposed significant alteration zones, that the potential severity and risk of falls of ground in these zones were understood. As shown in Figure 4, it is extremely difficult to support these zones as it unravels around support units. If it occurs higher up in the HW, it can cause significant instability. Thick zones directly above the UG2 Reef also contributes to significant dilution that can cause certain blocks of ore to be uneconomical to mine.

Figure 7. Remedial strategies where weak, clay-like (alteration) zones are present.

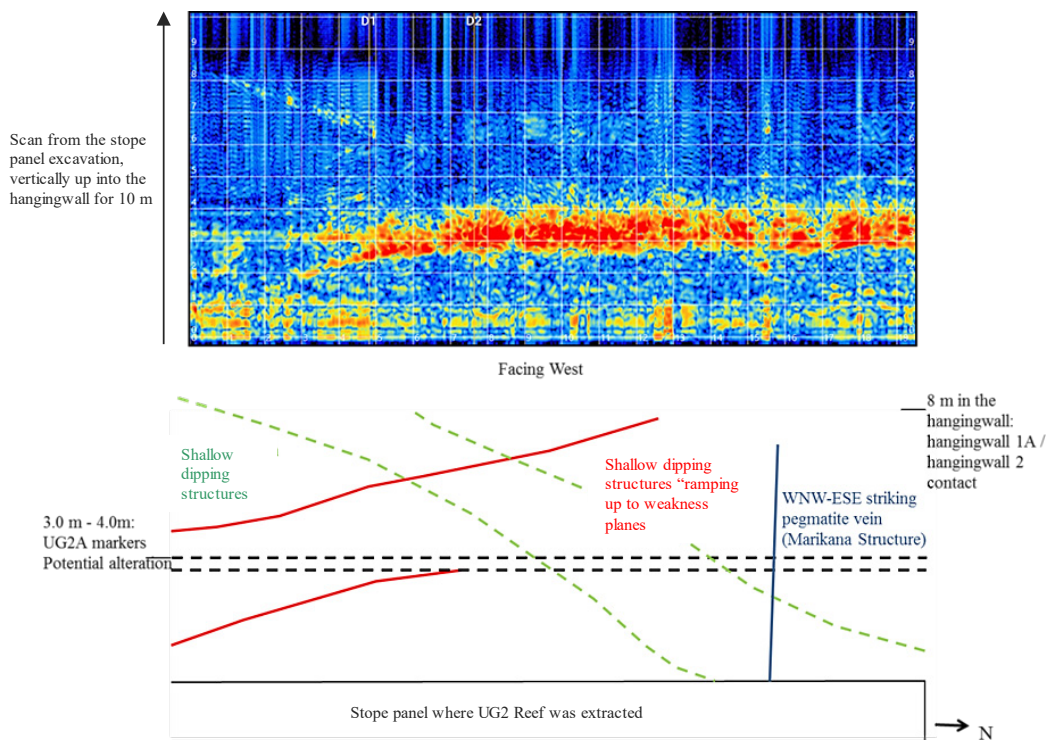
Multiple site investigations were conducted at underground operations and the studies included geologic mapping and the use of the GPR. Figure 5 illustrates the scanned image along a mined-out stope panel for 19 m. The interpretation from this GPR scan is also shown in Hartzenberg (2019). Notice how the ramp structures ‘ramp up’ to potential weakness planes. These are also possible sources/locations of alteration zones. The red zone from the scanned image confirms that a significant alteration zone is present along the UG2A markers (thin chromitite layers that act as natural parting planes). The presence of alteration zones was also confirmed by drilling into the HW, with careful consideration of the clay-like layers that are present.

Figure 5. Top: Sub-surface scan of a section into the hangingwall. Bottom: Interpretation of the hangingwall section, showing the stope panel, potential parting planes, geologic structures as well as an alteration zone along the UG2A markers. The WNW-ESE striking Marikana Structures cause significant instabilities and should be considered when the direction of mining is determined.
