Rehabilitation of old masonry tunnels – challenges and possibilities

Tilman Sandner, Claas Meier
Boley Geotechnik GmbH, Munich, Germany

ABSTRACT: The Reicholzheim tunnel on the single-track line 4920 from Lauda to Wertheim had to be rehabilitated, since the existing tunnel lining, made of mortar sandstone blocks, is in a structurally poor condition. To rehabilitate the tunnel, the existing masonry shell was reinforced with a self-supporting reinforced concrete inner shell. The low clearance profile required partial removal of the masonry. Due to the vibration-sensitive structure and high rock strength, the milling work had to be carried out on the basis of a separate safety concept including high-pressure water cutting. To secure unstable areas of the vault, CFRP safety devices were installed. Due to the partly non-existent back-fill and the narrow time window during night-time closures, special requirements were placed on the concreting. As the responsible design-review-engineer, the design and compliance with the railroad regulations with regard to the innovative safety and rehabilitation measures were also challenging.

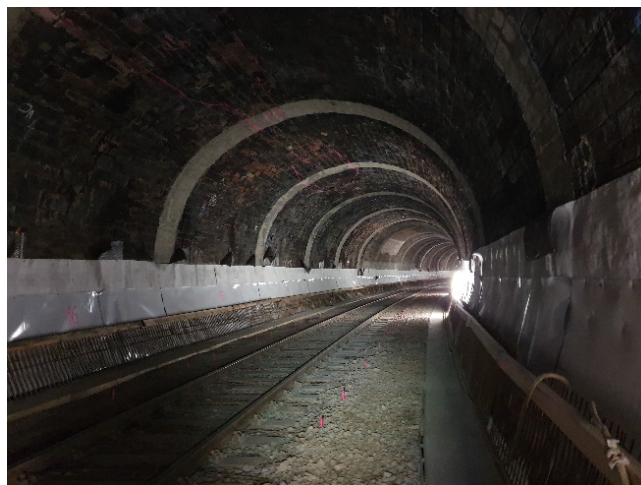
The existing tunnel lining of mortar sandstone blocks is in a structurally poor condition. This is reflected in washed-out joints, breakouts, spalling, cavities, efflorescence and leaks in the form of water seepage. To maintain operational safety for rail traffic, parts of the vault were therefore temporarily secured. The portal structure, protected as historical monuments, have also become

Figure 1. Existing shell of mortared sandstone blocks [source: Boley Geotechnik GmbH].

For the rehabilitation of the tunnel with its horseshoe profile, the existing tunnel lining made of natural stone had to be reinforced by a self-supporting reinforced concrete inner lining in cast-in-place construction (Antony C. et al. 2021). The new inner lining was initially planned with a thickness of 35 cm in the ridge area and 45 cm in the elm area. It was founded on the existing rock on both sides via strip footings. To allow installation of the new inner lining, the existing masonry had to be removed in some areas. To seal the tunnel against strata and seepage water, a roof sealing made of a geomembrane was planned. The geomembrane was to be connected on both sides to a new drainage system that also had to be constructed.

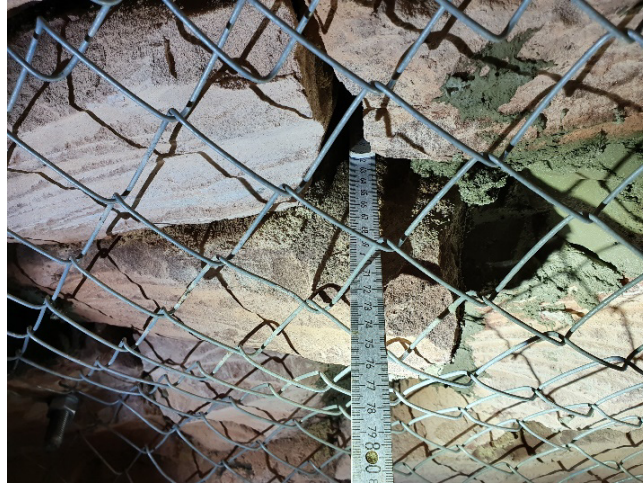
The masonry mortar is heavily weathered in some areas or completely decomposed and washed out. Due to the poor condition of the mortar, several sandstone blocks came loose from the masonry structure during milling works in the tunnel roof. As the appointed EBA (federal rail agency) design-review-engineer, we were immediately commissioned by the client to assess the condition of the vault in consideration of the safety of rail operations during the day. In Germany all designs for rail structures need to be reviewed by an EBA approved design-review engineer (the so called *Prüfingenieur*). The design-review engineer performs the structural and/or geotechnical analysis of the designs to confirm that all design standards are fulfilled.

At the time of the inspection, the masonry vault apparently showed no fresh deformations of the overall profile. The high degree of opening of the joints as seen from the tunnel floor and the number of flaws in the freshly milled area were clearly less pronounced on closer inspection. Since the masonry blocks were only roughly hewn, they showed a corresponding interlocking or wedging over the depth of the joints. On the basis of the assessment, the conclusion was that, at the time of the inspection, the masonry bond was considered predominantly stable and therefore no acute risk to the stability of the structure was to be expected (Antony C. et al. 2021).

Figure 2. Loosened and temporarily secured sandstone block [source: Boley Geotechnik GmbH].

To prevent hazards to rail operations, an immediate placement of perforated plates and plaster indicators was arranged to monitor any movement in the masonry (Balbi G. et al. 2021).

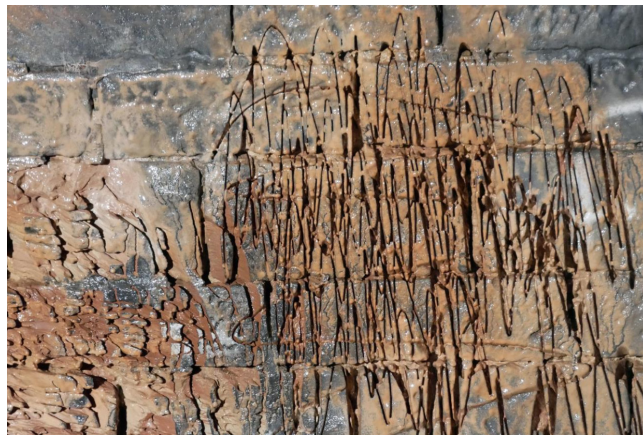
In order to be able to continue the work, a safe procedure was required, which included two different methodologies. Loosening by means of high-pressure water (HPW) cutting was successfully tested as a low-vibration method, but this was associated with a high cost and an unfavorable surface finish and/or necessary reworking (Breuning V., et al. 2011).

Figure 3. Surface of the masonry after tests with HPW cutting [source: Holzhäuser Ingenieur Consult GmbH].

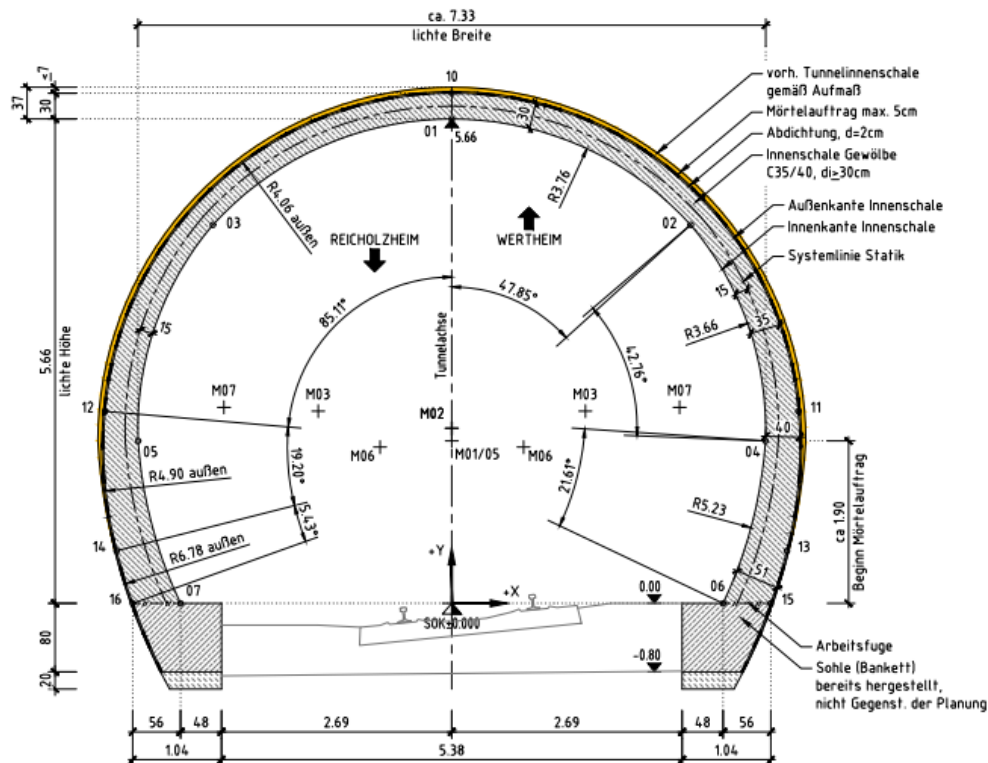
In order to significantly reduce the extent of the removal work on the existing shell and to avoid having to work on particularly critical areas of the masonry, the contractors proposed to reduce the planned thickness of the inner shell in the ridge from 35 to 30 cm.

However, RIL 853 stipulates a target thickness of 35 cm. In consultation with DB on the interpretation of the RIL, it was decided that from the point of view of the infrastructure manager ("Anlagenverantwortlicher") and the design-review-engineer, a reduction in the shell thickness in accordance with the RIL could be agreed upon. Ultimately, it was possible to design the inner shell predominantly with minimum reinforcement and in accordance with RIL 853.

Figure 4. Cross section of the inner shell tapering towards the tunnel roof [source: müller + hereth GmbH].

The reduction of the inner shell thickness also allowed for the increased application of a sprayed mortar lining. In the original planning, it was envisaged within the scope of a special internal approval (UIG) that the insertion of a sealing support between the existing masonry and the geomembrane could be dispensed with. However, it became apparent during the execution that sufficient surface roughness could not be produced with the solution methods of milling and high-pressure water cutting. It was therefore decided to apply a leveling layer of sprayed mortar, which acted as a sealing support. An additional advantage of the sprayed mortar layer was that it made it much easier to insert the nails for the geomembrane's anchoring (Balbi G. et al. 2021).

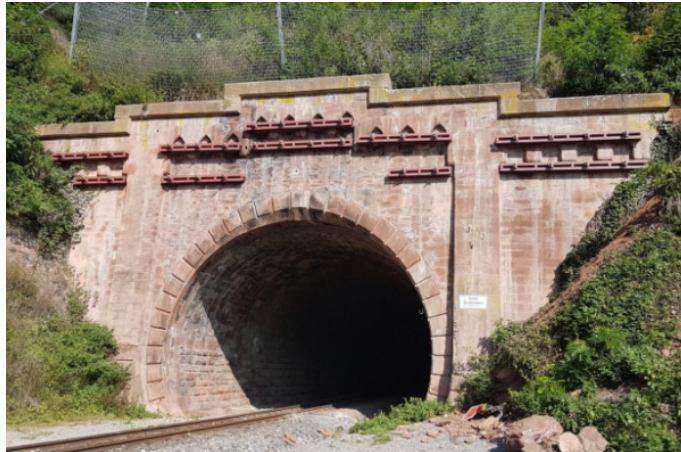
Figure 5. Tunnel portal with temporary retaining system [source: Boley Geotechnik GmbH].

The tunnel portals are no longer stable due to the age of the structure and the slope movements near the surface. In the area of the portals, temporary retaining systems were therefore constructed consisting of a waling beam with rock nails. Due to the requirements of monument protection, the securing means are to be replaced by a permanent and non-visible retaining system.

From the design-review engineer's point of view, the planning is problematic because integrating the existing nails into a new system cannot meet the criteria for durability as per manufacturers specifications. The development of the stress conditions while working on and around the prestressed nails could also not be predicted with sufficient certainty. In addition, there were problems due to the confined space conditions required in the area between the anchoring.

A detailed design is therefore currently being finalized, which envisages a complete replacement of the existing system. To do this, the slope behind the portal walls must be secured by installing new rock nails in a u-shaped concrete structure before the existing rock nails can be removed. The masonry is then tied back into the concrete structure via vertically drilled CFRP-anchors.
