Structural and Geotechnical Investigations for the Remediation of Jetties and Seawalls on Heligoland

ABSTRACT: Heligoland is a German offshore island located about 50 km from the German coastline in the North Sea. Storm surges, especially in 1954, caused massive destruction and damage to the jetties and seawalls. Moreover, the "Big Bang" blast in 1947 as well as wartime bombardments lead to extensive rock fracturing.

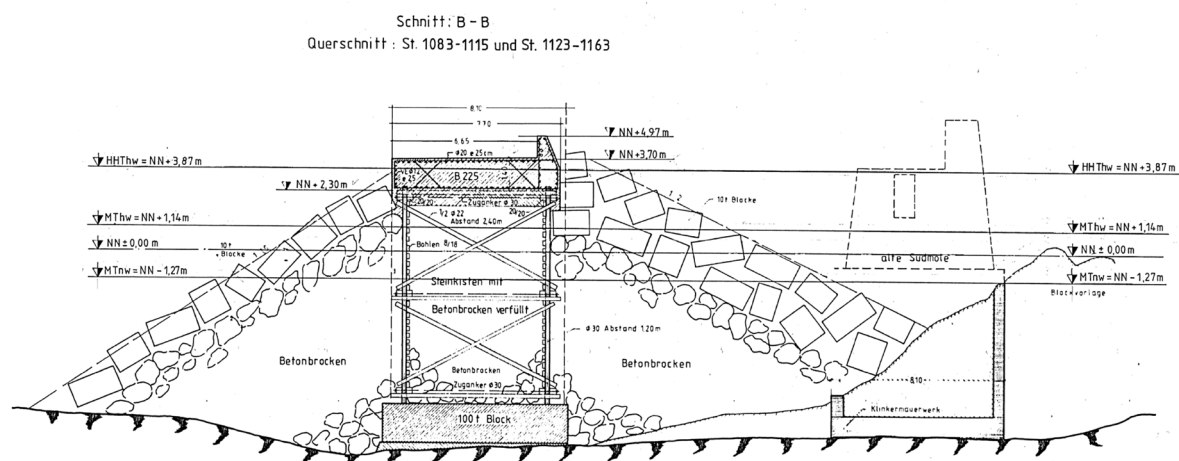
Figure 2. Seawall construction after storm damages within the southern seawall.

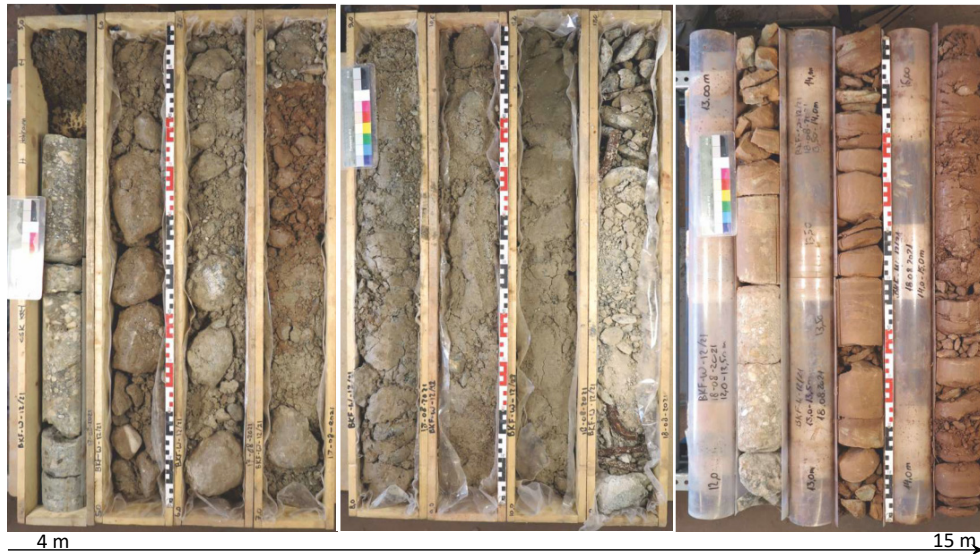
Figure 3. Core from Boring BKF -W-12/2021; 4 m to 15 m.

An example of the core recovery is shown in figure 3. It shows cores taken from the structural concrete (4 m to 4.75 m), the backfill (until 11 m), the base concrete (until 12.5 m) and the rock in the interface to the foundation. Massive steel parts at the base of the backfill did not affect the core recovery.

Using the recorded drilling data a gap of around 15 cm between the structural concrete at -4,75 m and the top of the backfill could be detected.

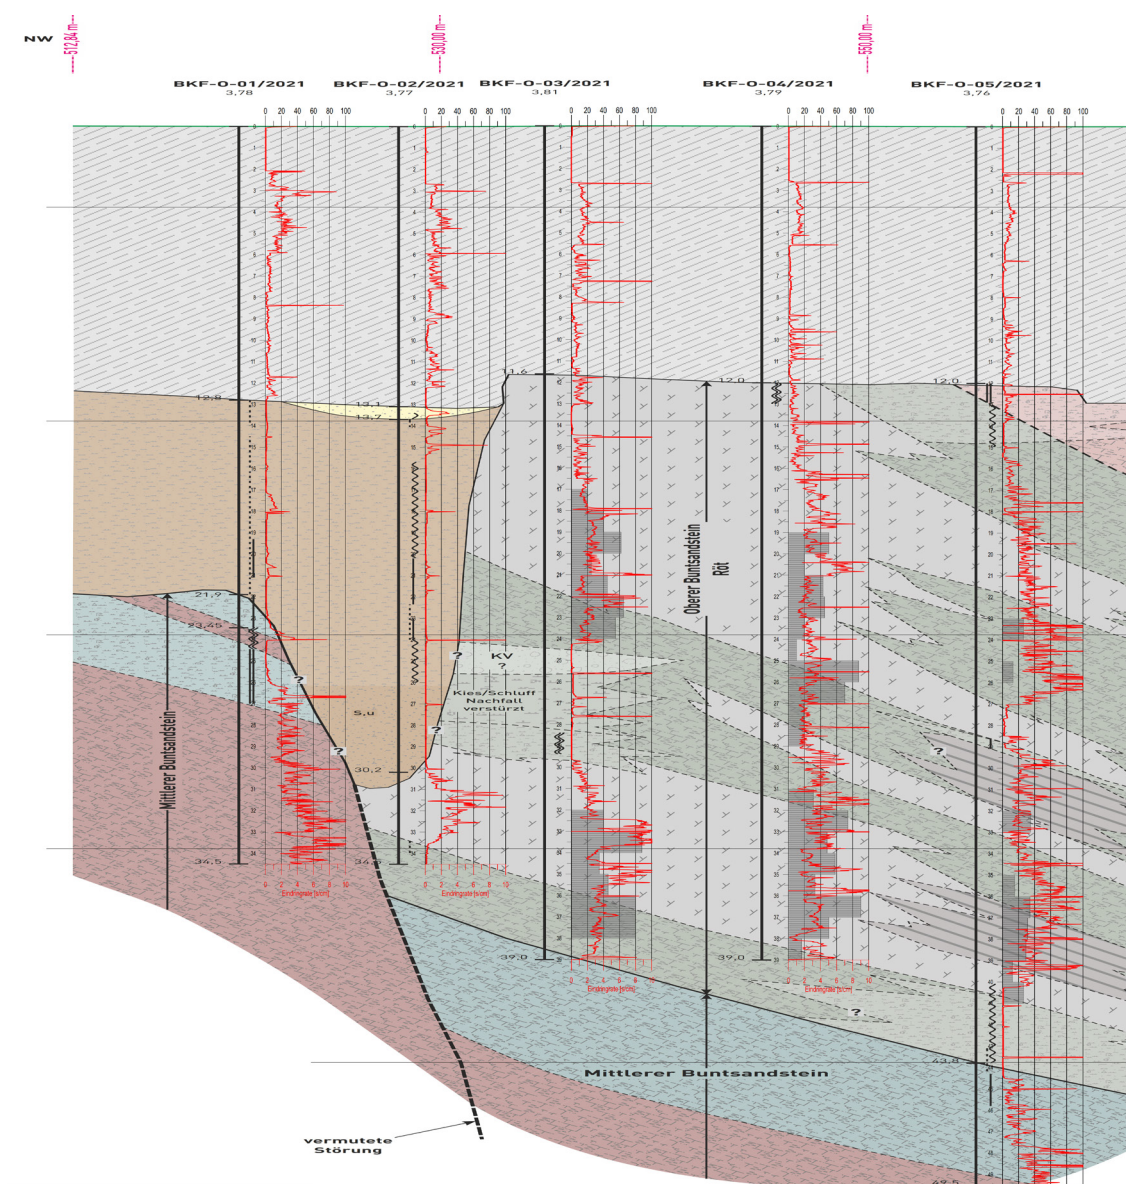
Figure 4. Detail of the geological underground model at the eastern seawall (length around 50 m).

Figure 4 shows a detail of the underground model at the eastern seawall. Both, stratigraphy and quality of the soil and rock could be described in the model in detailed, even heterogeneous conditions have been found in this area. Quaternary sediments in the filled sinkhole, soils and weak rock of the leached sulfate formation could be investigated with sonic drilling, in rock formations and remaining gypsum layers wireline drilling was used.
