# Rock cut slope excavated for Settling basins of Seti Khola Hydropower Project

Krishna Kanta Panthi

Chhatra Bahadur Basnet

**ABSTRACT:** Stability of a cut-slope at the headworks area of the hydropower projects is very important for smooth operation of hydropower plant. Underestimation during construction period may bring a catastrophic consequence. This manuscript presents overall assessment results of the rock cut slope excavated to accommodate two settling basins of Seti Khola Hydropower Project (22 MW) located at Lekhnath, Kaski, Nepal. The height of the cut slope is about 50 m and is among the most challenging part of the construction work. The cut slope is excavated in a highly schistose and deformed phyllite with interbedding of metasandstone layers. The evaluations are made on the overall rock mass and discontinuity characteristics. The results of detailed stability assessment using software program SLIDE in consideration with both normal and seismic loading conditions are presented. Final rock support measures are proposed to ascertain long-term stability of the cut-slope.

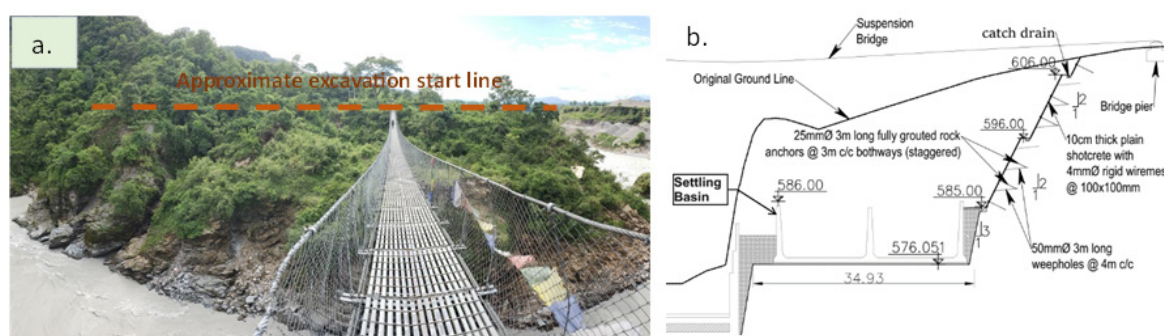
Figure 2. a. Photo showing the slope to be excavated for settling basins, b. originally designed of cut-slope.

The cut-slope excavation was continued up to elevation 590 masl, the second bench in Figure 2b. The combination of 25 mm diameter and 3 m long rock bolts and 10 cm thick reinforced shotcrete was applied as support measures. After reaching elevation 590 masl, a tension crack appeared at the top of the slope and the slope started creeping forming cracks in the cut slope (Figure 3a) indicating that the rock mass is incapable to hold a bench inclination of about 65 degrees. Hence, a decision was made to unload the upper part of the slope as such that the upper part of the cut slope has an approximate angle of 42 degrees (Figure 3b). In addition, longer rock bolts were proposed to be installed below elevation 591 masl.

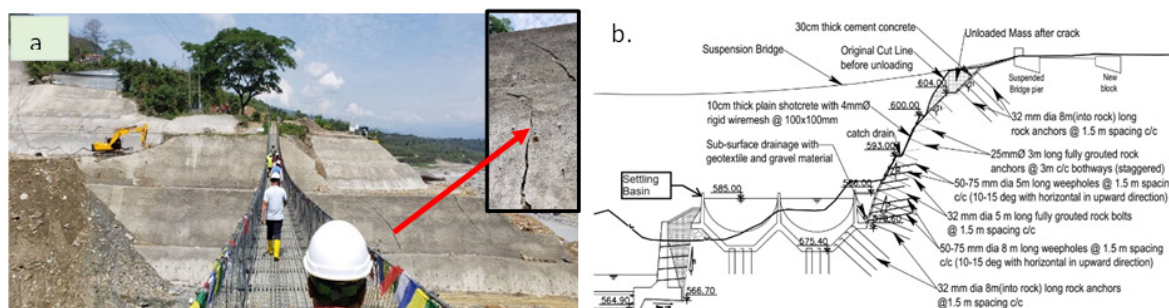
Figure 3. a. Excavated cut slope showing developed cracks, b. revised design of cut-slope with unloading.

Even after this unloading, cracks were continued to develop while cutting the slope further down which led to carry out through stability assessment and redesign of the cut slope. Stability analysis of cut slope at selected sections with modified support patterns is presented in this manuscript below.

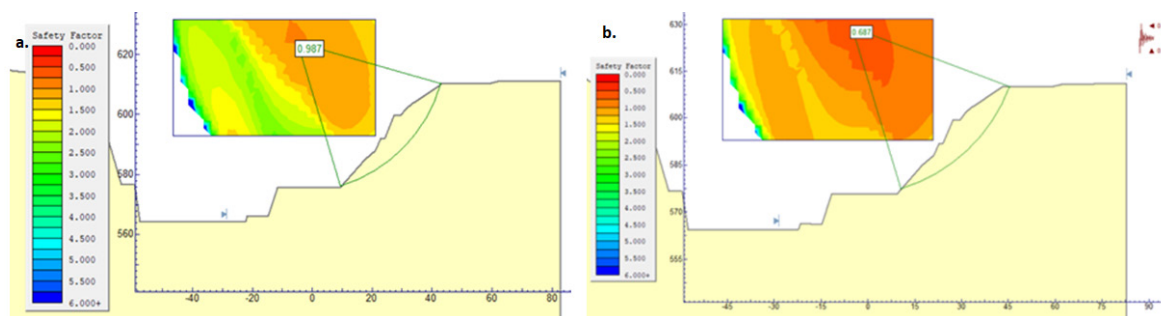
A comprehensive analysis using SLIDE indicated that the original slope was critically equilibrium at the banks of the Seti River. Figure 4 shows the stability condition at the cut slope after excavations for both normal and seismic loading conditions. As can be seen in the figure the cut slope is at critical stage with FoS below one at normal loading condition and at failed state at seismic loading condition.

Figure 4. Achieved factor of safeties before support measure. a. At normal, b. At seismic loading conditions.

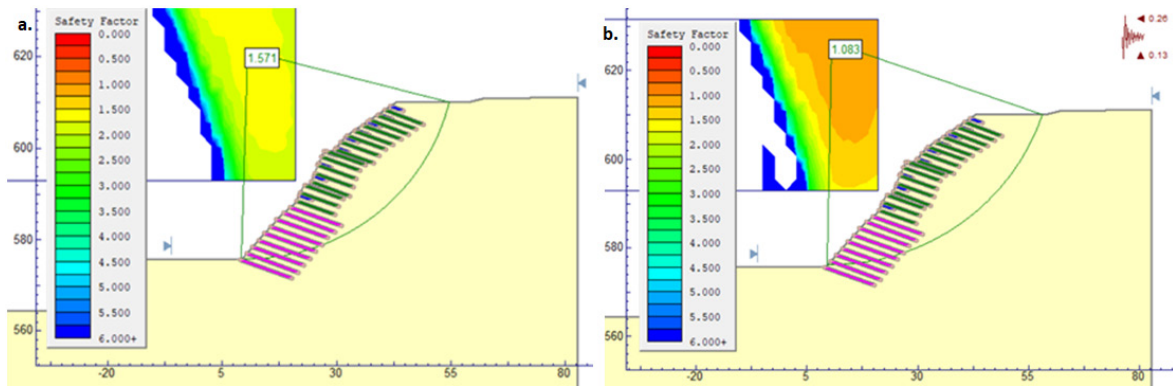
enhancement of the Factor of Safety (FoS) for both normal and seismic loading conditions. As one can see, the achieved FoS for normal loading condition is above 1.5 and for seismic loading condition around 1.1 which is considered to be safe enough for this project.

Figure 5. Achieved factor of safeties after support measure. a. At normal, b. At seismic loading conditions.

As one can see in Figure 5, the much longer rock bolts were required to stabilize the cut slope. Especially this is the case for the failed lower part of the cut slope (Figure 3a) which lies below elevation 592 masl. Based on the assessment results a final design decision was made with a support measure shown in Figure 6 considering long-term safety of the cut slope.

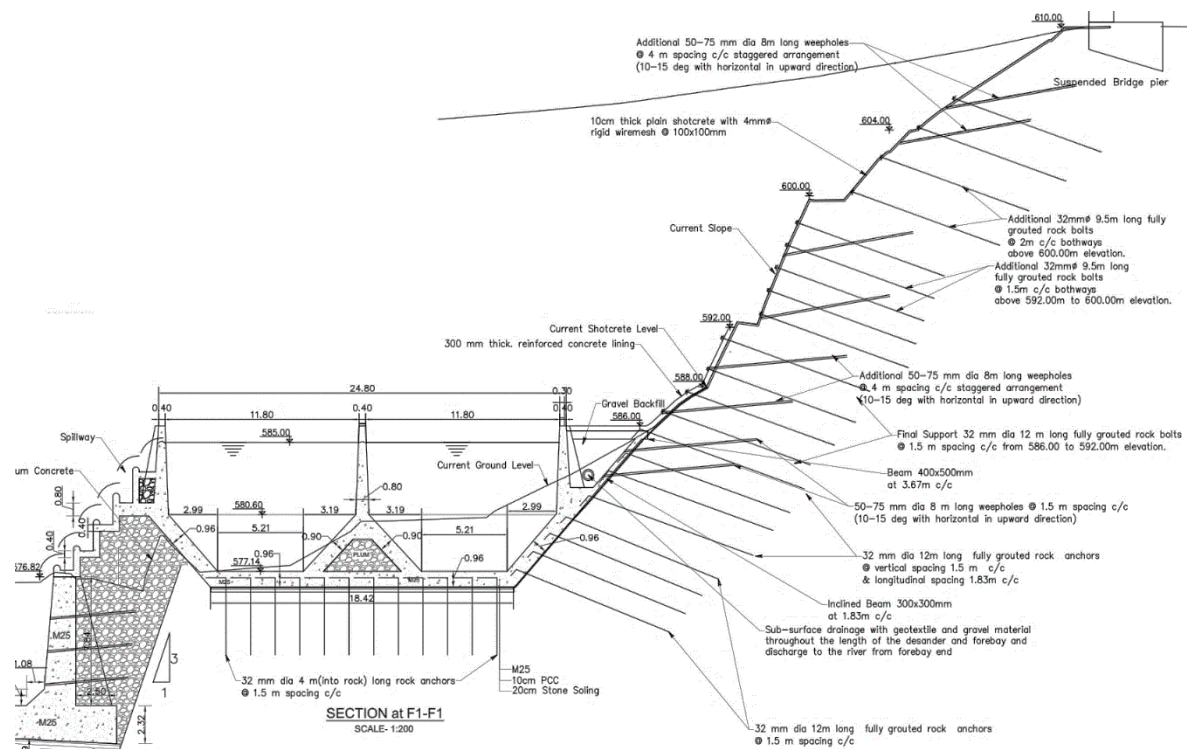
Figure 6. Final design arrangements of the settling basins with fully supported cut slope.

As seen in Figure 6, in addition to 10 cm thick reinforced shotcrete, the cut slope is supported with patterns of bolts having 32 mm diameter with varying length. The primary bolt length is 9.5 m long placed at 2 m spacing above elevation 600 masl, at 1.5 m spacing between elevation 600 and 592 masl and 12 m long bolts spaced at 1.5 m below elevation 592 masl. More importantly, grouted rock bolts have been used where the grouting was done during bolt installation at each hole to strengthen the rock mass of the cut slope. The grout (2:1 to 1:1 water cement ratio with bentonite in water

bearing area and plasticizers having non-shrinkage properties were used) consumption was in considerable amount in most of the holes (more than 300 kg cement per hole in average with maximum 750 kg). In addition, drainage weep holes having 50 to 75 mm diameter and 8 m long are being implemented to ascertain that the ground water built up is avoided in future. A subsurface drainage system is also considered at the bottom of the cut slope at the hill side of the right wall of settling basin. The whole cut slope has been excavated using this modified support pattern and no further movement have been noticed.
