Pavement failure and flooding of tunnel in limestone geology

Hong-Gyu LEE

Oriental Consultants Global, Tokyo, Japan

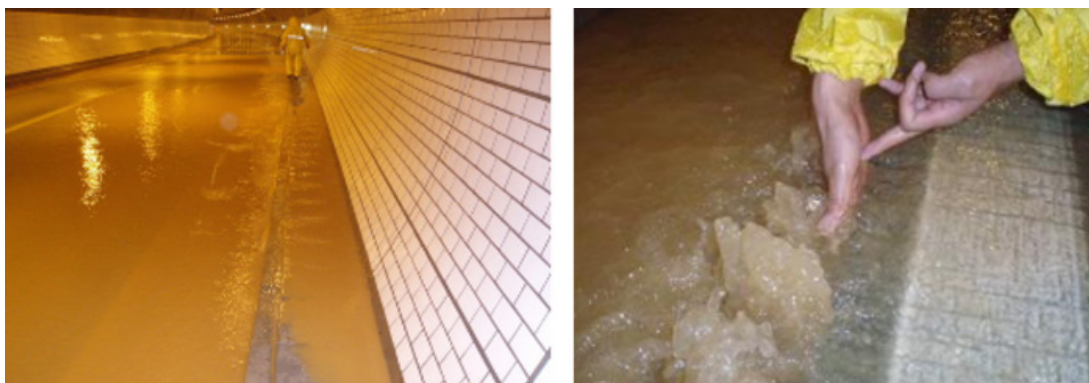
During 2 days of heavy rain with the total of rainfall of 233mm, the concrete pavement (thickness $t=30\text{cm}$) of the 970m-long tunnel in service was damaged. Groundwater flowed into the tunnel causing a flooding of about 500m-long section and disruption of traffic flow (Figure 1). The damaged section occurred at around 240m from the tunnel portal. Upon investigation of 2 days after the incident occurred, based on the level difference to upper surface of the shoulder, a rising phenomenon of pavement concrete due to lifting (up to 78mm) was confirmed. The occurrence of concrete cracks (maximum crack width of 22 mm) was also confirmed intensively in the 10m section where the rising phenomenon was the most prominent (Figure 2, Figure 3).

Figure 1. Flooding and groundwater inflow in tunnel.

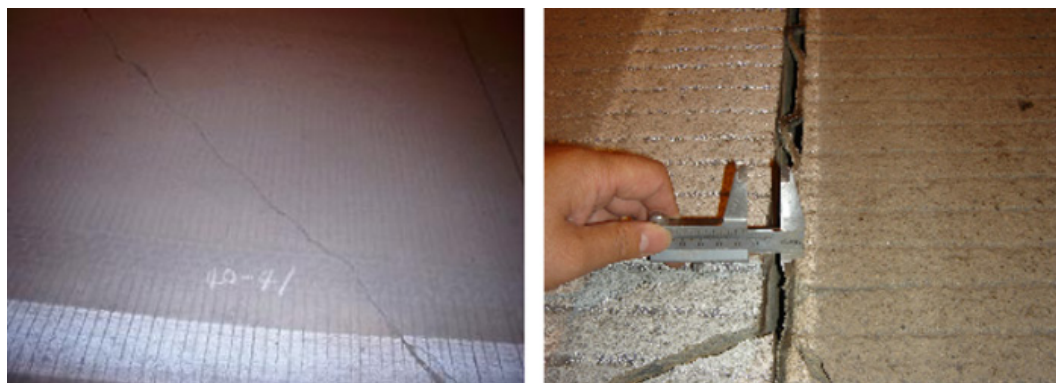
Figure 2. Damage of pavement concrete.

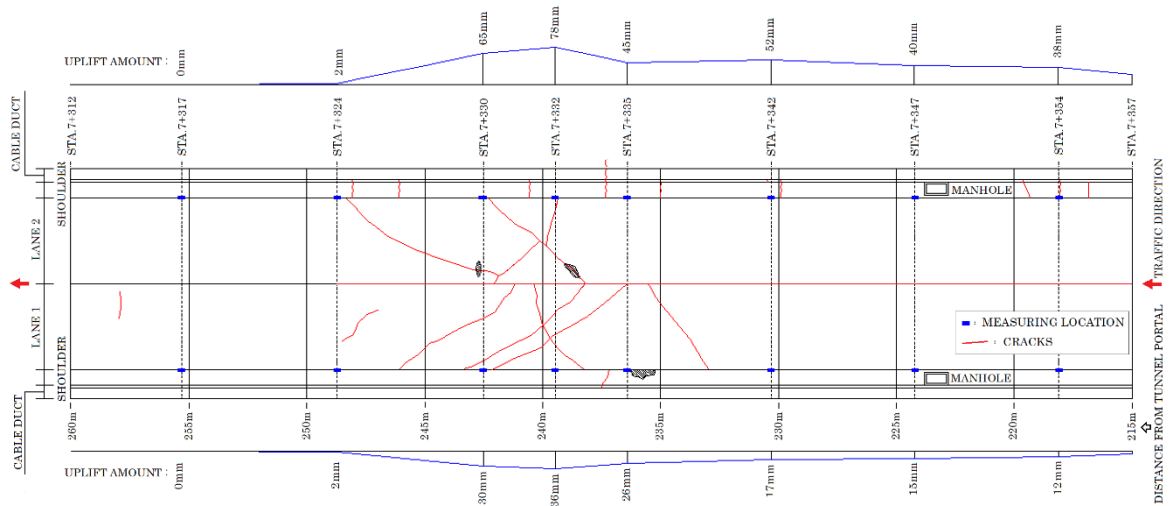
Figure 3. Details of damaged pavement concrete.

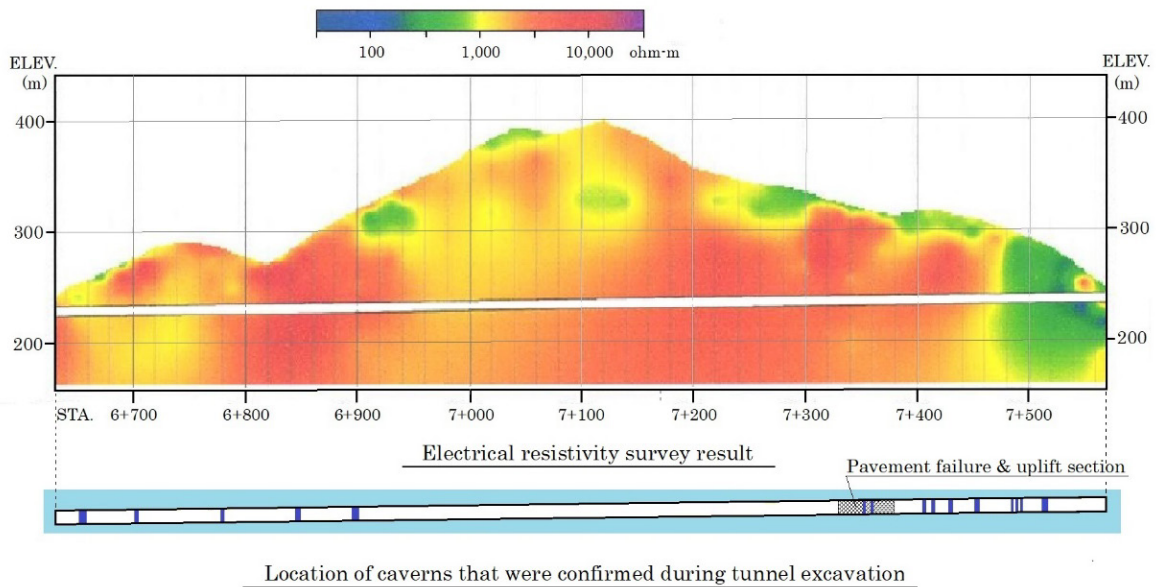
Figure 4 shows the longitudinal section of the tunnel, the result of the electrical resistivity survey and the location of the caverns that were confirmed during excavation. The tunnel has a maximum overburden height of about 160 m. The existence of a cavern was not confirmed in the section with high overburden height at the center of the tunnel, however, 15 caverns with a continuity of 2 m to 8 m were identified in the section below 100 m of overburden height. Location where the pavement was damaged or uplifted is also in section with overburden height of about 80m.

Figure 4. Result of electrical resistivity survey result and location of caverns that was confirmed during tunnel excavation.

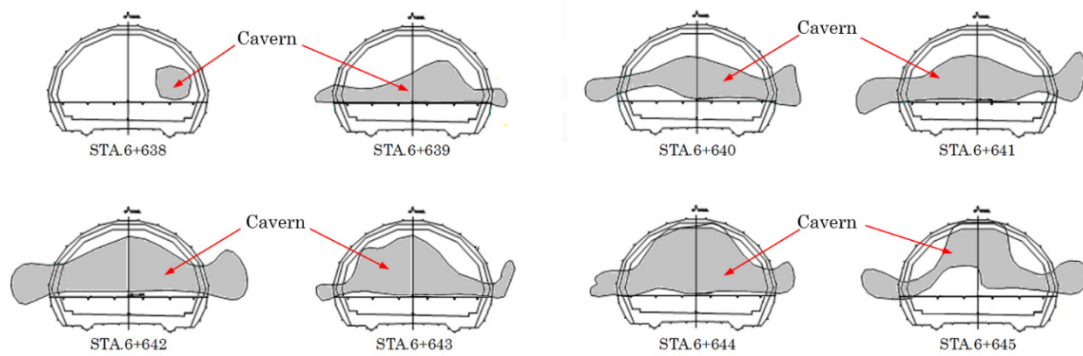
The shapes of the caverns are all different. Figure 5 shows the shape of the cavern with the longest extension in the longitudinal direction at 1m intervals. Larger caverns were not identified. The caverns were later filled with shotcrete.

Figure 5. Example of distribution of cavern that was confirmed during tunnel excavation.

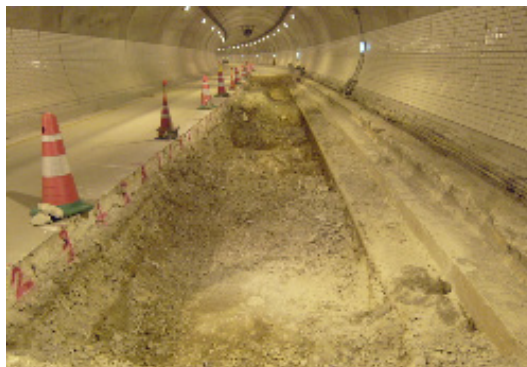
At one location clearly identified as a cavern, the excavation surface consisted of hard rock of limestone. However, a wedge-shaped loose soil was also observed in some part. As a result of removing the soil, groundwater flowed out, and a cavern with the entrance diameter of about 30 cm was identified at a depth of about 1.0 m from the bottom of the side drain pipe (Figure 7). This cavern located directly below the section where the damage of the pavement concrete was most noticeable, with a horizontal length of about 1 m and a horizontal width of about 40 cm. However, it was not possible to ascertain the connection to the adjacent cavern. At the other 4 locations, weak zone with a width of around 50 cm was identified between hard rocks, which could be connected to the cavern and was presumed to be in the process of erosion.

Re-investigation of original excavation surface under pavement concrete

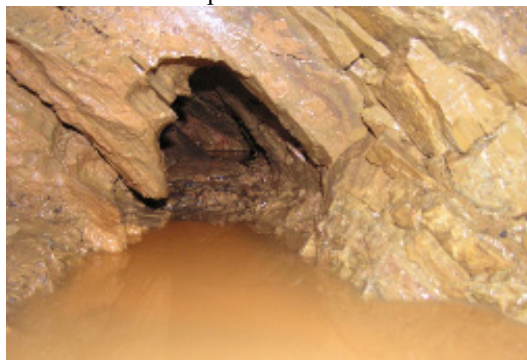
Small cavern found 1 m below side drain

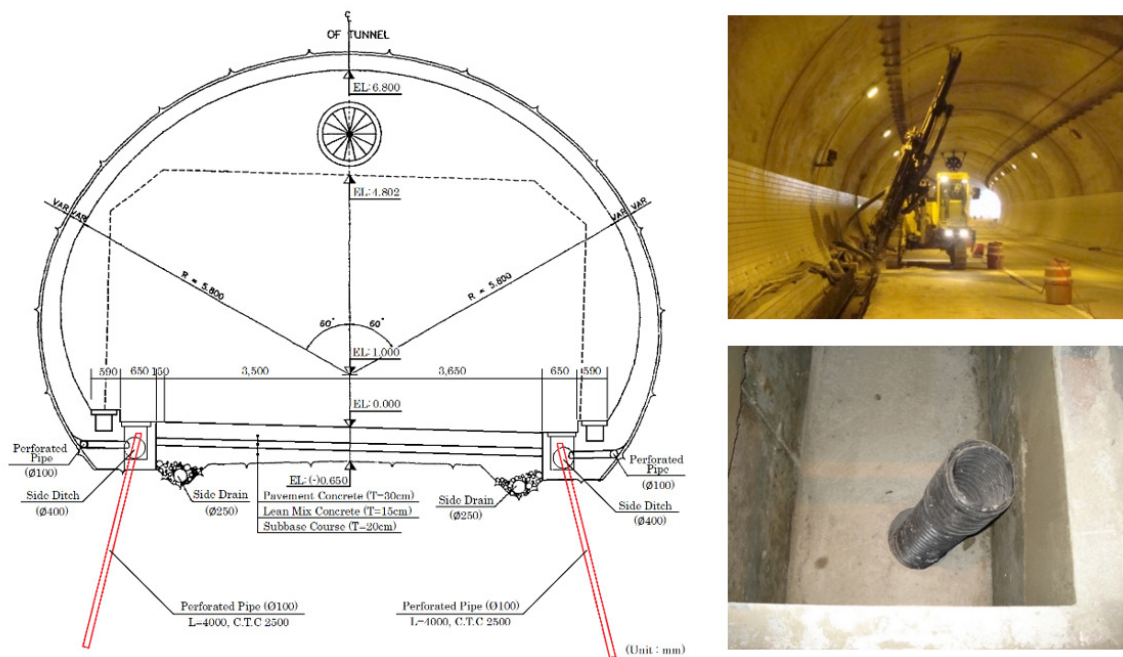
Figure 8. Countermeasure using drainage boring and related photographs.

As a result, after changing the side ditch composed of a spiral pipe to a manhole cross section in the entire 46m section where the pavement concrete was lifted, 4m long perforated pipes were installed at intervals of 2.5m (Figure 8). In addition, PE pipes were connected to the side ditch from 5 small caverns identified under the pavement concrete to side ditch to drain groundwater.
