Design Review of the Remediation Project of a Highly Weathered Open Pit Wall from a Closed Iron Ore Mine in Brazil

José Allan C. Maia, Teófilo Costa
Vale S.A., Belo Horizonte, Brazil

Anderson Fonini, Felipe Gobbi, Ricardo Menezes, Gonçalo Sonaglio, Fabiano Madrid
FGS Geotecnia, Porto Alegre, Brazil

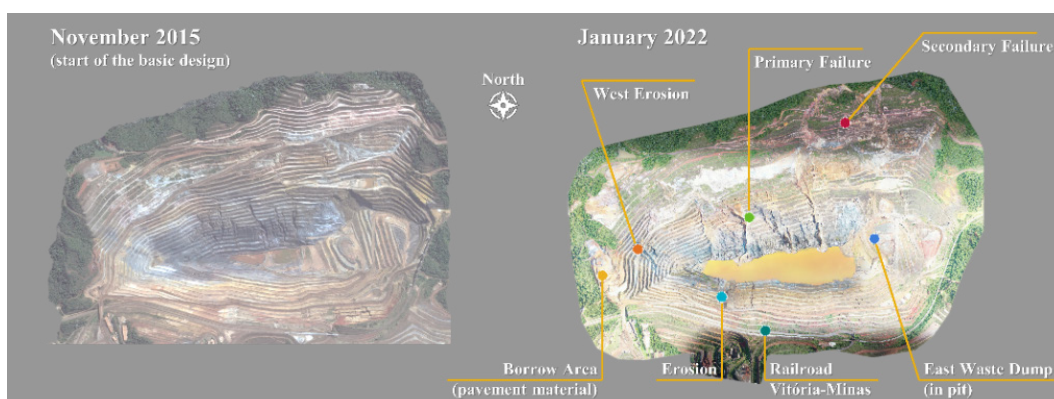
Figure 1. Open pit view in November 2015 (start of the basic design) and January 2016 (no works deployed).

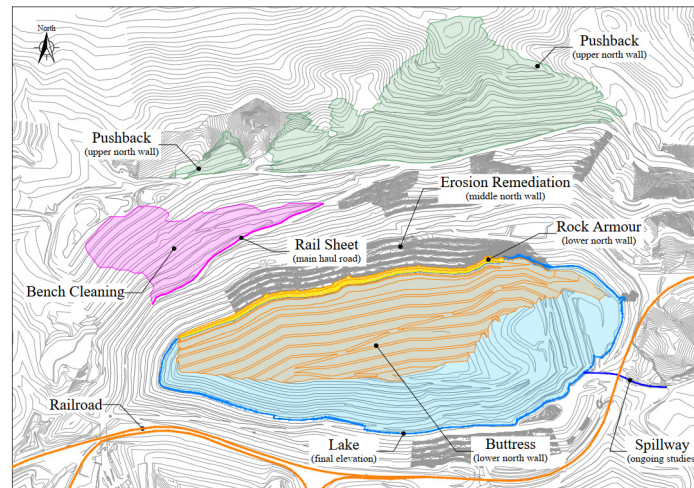
Due to Scenario 2 needing further studies related to tailings behaviour and its influence on the local hydrogeology, Scenario 3 was selected and developed as the 2016 Basic Design (Figure 2). Both solutions delivered similar results about FoS, probability of failure (PoF), and risk management.

Figure 2. Remediation works proposal by the 2016 basic design (Pimenta de Ávila, 2016).

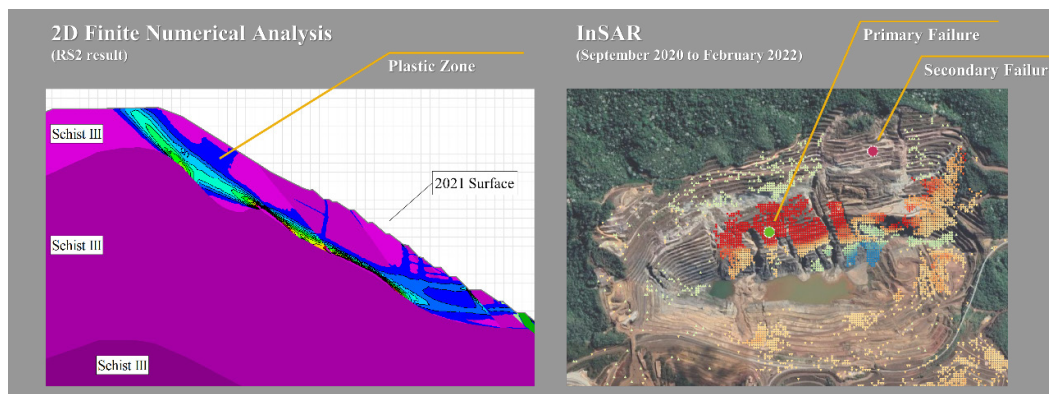
Regarding secondary failure, the first stages of excavation showed conditions that were very close to the stability limit. The numerical results indicated that the lower portion of the north wall had expressive displacements and a concentration of shear components, although more minor, but in a large area without necessarily an unstable surface deployed. Those are also according to the displacement data evaluated from the orbital monitoring record (InSAR) shown in Figure 3.

Figure 3. Computed slip surface in the secondary failure area and the displacements reported by InSAR.
