Burgenland's first tunnel takes its tribute – geotechnical retrospective of a tunnel collapse

ABSTRACT: The tunnel Rudersdorf, which is part of the S7 Fürstenfelder motorway is a two-lane twin tube road tunnel with seven cross passages, and has a length of approx. 1.785 m. The overburden of Burgenland's first tunnel ranges between 2 and 72 m.

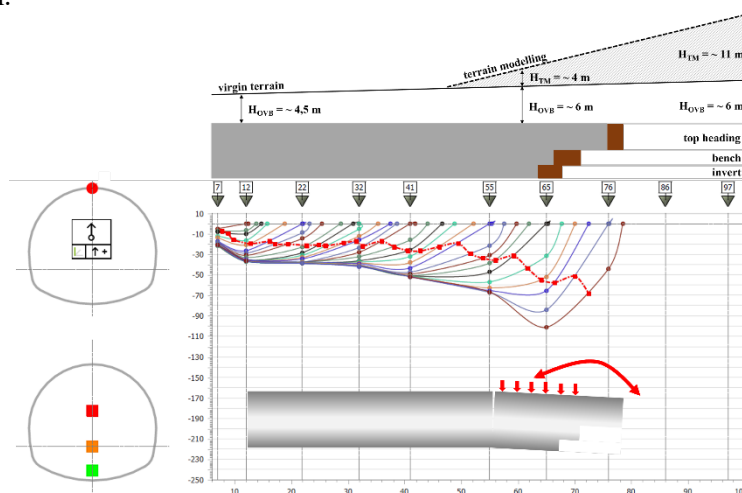
Day 1:

Identical longitudinal displacements at monitoring sections MS65 and MS76; stresses due to longitudinal strains dissipate through formation of a crack in circumferential direction at chainage 56.

Figure 1. Situation at day 1; construction phases (top), deflection lines for vertical displacements for the crown point (middle), kinematics of the shotcrete shell (bottom).

At this time, the unfavourable situation in the area of the partial cross section top heading and bench without ring closure becomes evident. The shotcrete shell features two adverse characteristics in the open bench section: Firstly, the shotcrete of the bench rests with its standard thickness on the ground. The elephant feet of the top heading have only limited effect since the ground in the vicinity of the elephant feet abutment gets disturbed by the bench excavation.

On the other hand, the partial cross section top heading/bench has low lateral stiffness due to the almost vertically aligned shell in the bench area. Mobilization of support pressure is only possible to limited extent until the complete ring closure is installed.

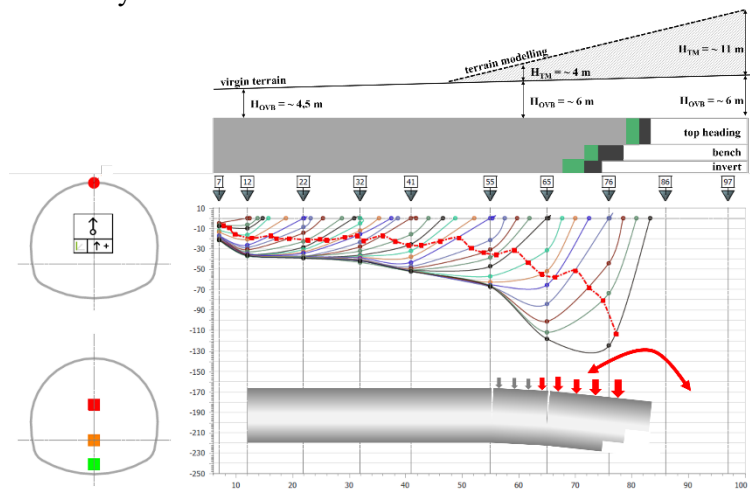
Day 3:

On day three, the measurements of monitoring section MS65 showed almost no increase of vertical displacements (Figure 2). A stress transfer behind the face, in the area with already installed ring closure, is not observable. Rather, stresses relocate and concentrate in the section of the open bench. Thus, leading to further strain concentration and overstressing in the ground and hence formation of new shear failures and existing shear bands propagate outwards and upwards. Due to the low thickness of natural ground the development of a longitudinal arch is limited, and the ground is forced to transfer loads solely via transverse arches, resulting in a high degree of utilisation of the ground's shear strength. The high vertical displacements lead to tilting of the stiff shotcrete shell in the area of the already installed ring closure. This in turn imposes high longitudinal strains on the shell in the crown, which became evident by the formation of cracks in circumferential direction.

Significant displacement increases at monitoring section MS76 (open bench); load transfer to the rear part (increase of vertical displacements 10 m behind the ring closure); constantly identical longitudinal displacements at monitoring section MS65 and MS76; formation of a crack in circumferential direction at chainage 65.

Figure 2. Situation at day 3; construction phases (top), deflection lines for vertical displacements for the crown point (middle), kinematics of the shotcrete shell (bottom).

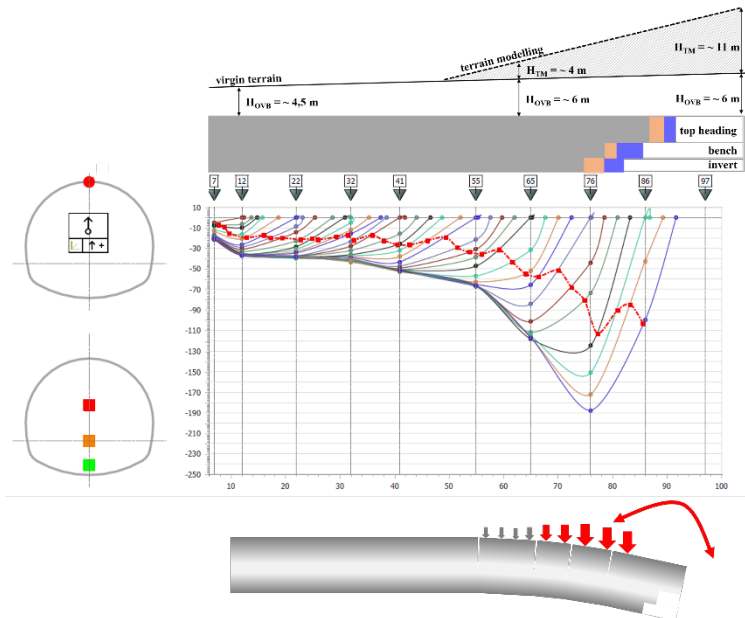
Day 6:

At day 4 and 5 identical longitudinal displacements at monitoring section MS65 and MS76 (further crack opening at chainage 56 and 65). Since day 4 no further vertical displacements at monitoring section MS65; Stresses concentrate in the ahead-lying area of the open bench; Formation of further cracks in circumferential direction at chainage 71 and 78, reduction of distance between cracks and top heading face ($> 20\text{ m} \rightarrow 12\text{ m}$).

Figure 3. Situation at day 6; construction phases (top), deflection lines for vertical displacements for the crown point (middle), kinematics of the shotcrete shell (bottom).

By considering the advance-oriented 3D monitoring data evaluation at day five, it seems the situation becomes less critical (orange deflection line in Figure 3). The ascending tendencies of trend lines may be interpreted insofar that the observations of the last days might have been a local problem.

The developments from day six on initiate the second phase of the failure process: Monitoring section MS86, at that time situated in an open bench area, shows high initial displacements (Figure 3). Due to high displacements one can assume that overstressing of the ground with formation of shear bands developing towards surface now also took place in the area around MS86. The overstressing of the ground and the ever-decreasing capability to transfer loads via longitudinal and transversal arches now covers a tunnel area of at least 20 m (approx. chainage 65 to chainage 86). The loss of the ability of the ground to bear and transfer loads is also reflected by the increase of vertical displacements at monitoring section MS76, whereby ring closure was already 6 m ahead of this section. The shotcrete shell is subject to further additional loads in areas that were already exposed to higher loads the days before. The excessive loading of the shell was revealed by more and more frequent formation of shear cracks in the shotcrete shell, in combination with a reduction of the distance between place of crack origin and tunnel face. Due to the radial perforation, a shear force transfer in the shotcrete shell is significantly impaired. Starting from chainage 56 the shotcrete shell is separated in approx. 10 m long slices in longitudinal direction. The radial cracks at chainage 56, chainage 65 and chainage 71 already show crack widths to a degree where a load transfer by frictional coupling in the formed circumferential joint is highly limited.

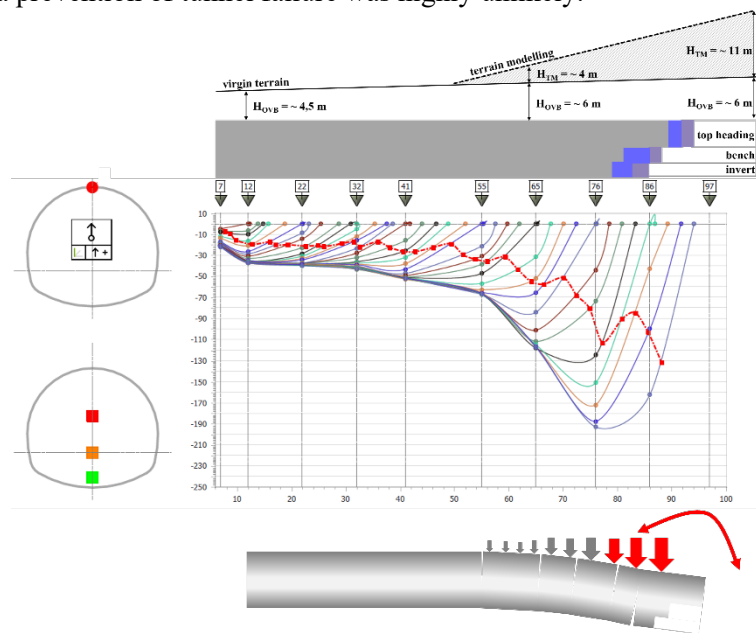
Day 7:

The concentration of loads on an increasingly smaller area becomes evident by the observations on day seven, where shear cracks in the shell were already developing at the transition bench/invert (Figure 4). The immediate formation of a damage (cracks) when the impact changes (e.g. bench excavation) is an indication that the load-bearing capacity limit of the shotcrete shell had already been reached. The tunnel support is now no longer able to follow the complex kinematics and is increasingly evading the load. On day seven, the overstressing of the rock mass and the shotcrete shell have progressed so far that a prevention of tunnel failure was highly unlikely.

No increase of longitudinal displacements at monitoring section MS65 and MS76;
 significant increase of longitudinal displacements at monitoring section MS86;
 loads concentrate on an ever-decreasing area (chainage 78 to top heading face);
 formation of a crack in circumferential direction at chainage 82 at the transition from bench to invert;
 load-bearing capacity of the shotcrete shell reached.

Figure 4. Situation at day 7; construction phases (top), deflection lines for vertical displacements for the crown point (middle), kinematics of the shotcrete shell (bottom).

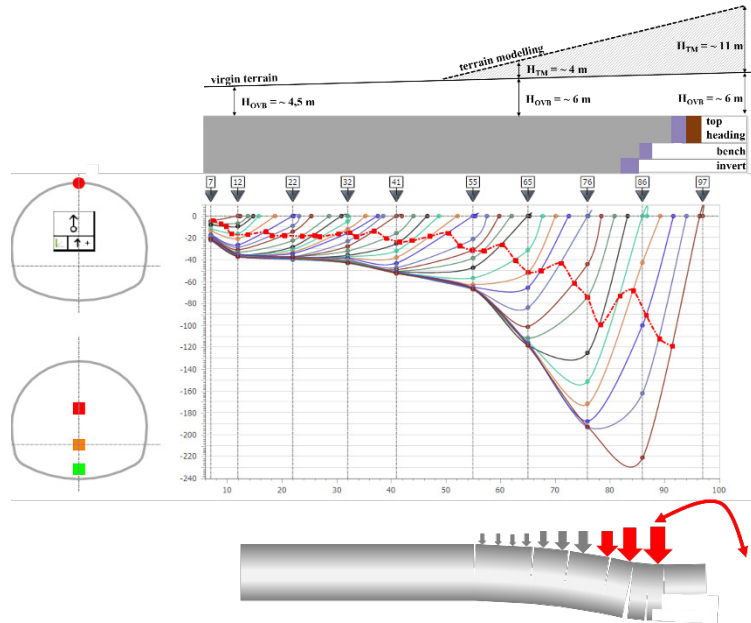
Day 8:

Due to the high loads on the shotcrete shell because of the overlying material in the crown area on the one hand, and the shear failure of the ground in the bench area, which yields to pushing ground in horizontal direction on the other hand, longitudinal cracks form in the shotcrete shell (Figure 6, left). A chain reaction is triggered: The shotcrete shell below the longitudinal cracks provides almost no support pressure against the laterally pushing ground. This results in progress of the shear failure in the ground and finally in the chimney type failure which happened at day 8 (Figure 5).

Load-bearing capacity of the shotcrete shell is reached between chainage 80 and chainage 90. Circumferential crack at chainage 82 entirely formed; new cracks at chainage 85 and 88,1; progressive increase of longitudinal and vertical displacements at monitoring section MS86.

Figure 5. Situation at day 8; construction phases (top), deflection lines for vertical displacements for the crown point (middle), kinematics of the shotcrete shell (bottom).

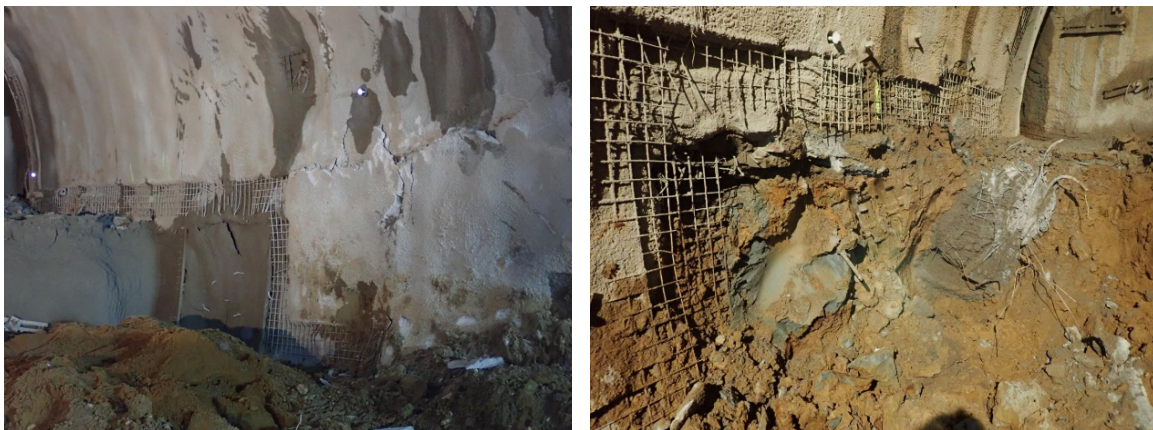
Figure 6. Crack formation/disintegrated shotcrete shell at chainage 85, right sidewall (left); left sidewall, bench excavation to chainage 94,3 – intact elephant foot and radial rock bolts of the top heading (right).

The tunnel collapsed on a length of about 30 m and led to a material ingress of approx. 1600 m³. During the course of the re-excitation up to chainage 78,5 an almost intact shotcrete shell at the side walls was observed. The separation edge of the collapsed shotcrete shell is situated close above the upper end of the elephant feet (area of lowest bending stiffness). The horizontally displaced elephant feet confirm the primary cause of failure of formation of shear failure at the bench: Up to chainage 80,9 the original shotcrete shell of the bench was intact, furthermore the invert was undamaged up to chainage 85,7. In this regard it became evident that the area of the shotcrete shell where longitudinal cracks formed, was completely damaged. In the portal section the bench and invert withstood the loading. A forward reaching cavity in the central lower face area of the top heading was determined. The lowered crown cap was intact. The parts of the shotcrete shell at chainage 87,7 showed a shearing of the shell above the elephant feet, analogously the area behind. During the re-excitation of the bench the sheared off elephant feet were found in their entirety (Figure 6, right).

The material pushes from outward in the area of the open bench, the elephant feet get sheared off and are shifted horizontally into the cavity. At the same time the shotcrete shell of the top heading, which is already severely damaged, fails. The cavity is thus filled almost simultaneously from the sides in the area of the bench and from above through the failed top heading shell. In the front area (projecting top heading shell) the shear fractures propagate at the upper end of the elephant feet. However, the shotcrete shell in the crown area still has sufficient residual load-bearing capacity so that it remains unbroken. This part of the shell is pushed downwards by the overlying material and pushes the elephant feet into the adjacent bench material.

- Measures underground/subsurface: extensive monitoring program (intensified monitoring interval for the 3D-displacement monitoring; installation of a face magnetostrictive extensometer, strain gauges in the shotcrete shell and in the inner lining, fibre optic sensors in the shotcrete shell and in the inner lining)
- Measures above ground: removal of the material for the terrain modelling to reduce dead load above the tunnel; installation of piezometer for measuring pore water pressures and their variation due to the excavation works, vertically aligned magnetostrictive extensometer to get information about the induced settlements due to the reconstruction of the terrain modelling and the influenced height above the tunnel.

The evaluation of the performed measurements has shown that the longitudinal displacement field of the tunnel face covers a length of 7 to 9 m ahead of the face. Based on this finding the length of the face bolts was increased and the residual bond length was increased to 10 m. Due to the intensified geotechnical monitoring program measures for the excavation works were continuously adapted.
