URUCUM Mine: Rockfall protection and monitoring system

Felipe Gobbi, Bruno Denardin da Rosa, Dione Henrique Dias, Nataly Ayumi Toma, Fábio Bertuol
FGS Geotecnia, Porto Alegre, Brazil

ABSTRACT: The access to Urucum mine is at the base of the Morraria de Urucum, composed of sedimentary rocks, a very steep rockface. Several rockfalls events in the past required that the company take action to mitigate risks, leading to a diagnostic and protective measures. Initially, the analyzes were based only on a point cloud, due access restrictions related to the pandemic period, resulting in a preliminary design of rockfall barriers and drainage. With the conceptual design, an extensive field mapping was performed, and the project revised, culminating in a drastic reduction of necessary interventions. The optimization it was possible through identification of differential weathering in the jaspilite strata, which allowed a new geomechanical model, better probabilistic analysis of block size distribution and thousands of rockfall simulations. This case is an interesting example of how the use of modern tools helps in projects, but it shows that they should be used with caution.

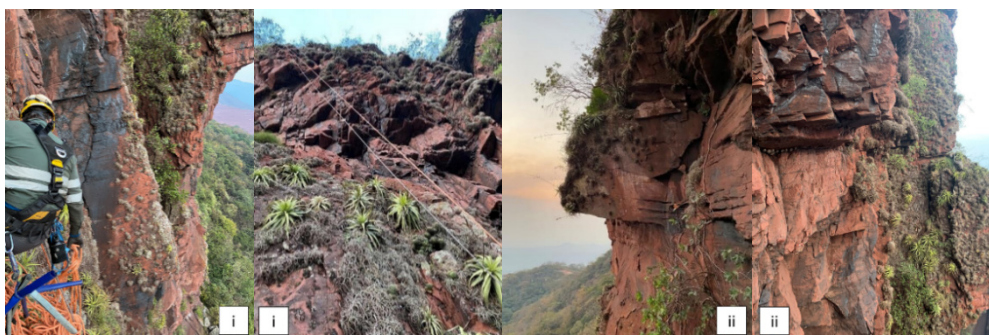
Figure 6. Typical condition of the rock face.

The rupture mechanism that conditions the detachment of the blocks on the vertical rock face was confirmed as initially predicted (drop and toppling). Stratification is favorable (about 13 degrees upstream), but the evolution of instability processes culminates in the formation of negative slopes, the greater the more intact the outcropping rock stratum. Different types of negatives were identified in the field: (i) staggered and (ii) massive.

Type (i), staggered, presents a sequence of displacements of submetric blocks, arising from the structural accommodation of verticalized fractures and the failure by traction of some stratified mineral levels. This set of factors ends up generating a staggered geometry of the negative, releasing small block in every event. Type (ii) massive, are the negative ones that occur in more resistant strata, and culminate in the individualization of larger potentially unstable blocks. This type is much less frequent than the first, during field inspections 5 of these negatives were identified. Both types of negatives are presented below.

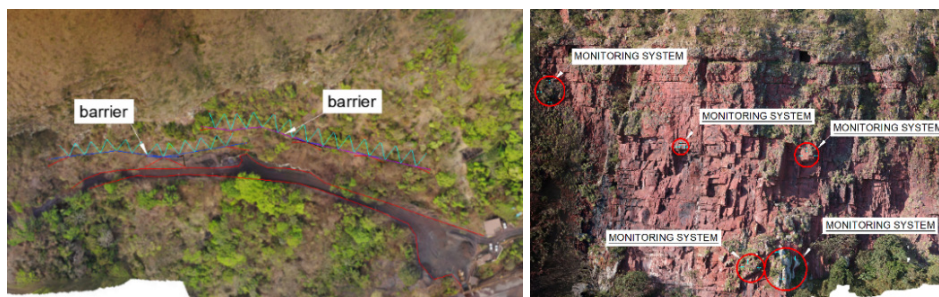
Figure 6. Final designed solution.

After the field inspections were concluded, block size distribution was reviewed on the probabilistic rockfall simulations. Rockfall dynamic barriers was designed for boulders from the crest and instabilities type (i) from the rockface, and an alarm system was designed for instabilities type (ii).

The new results have showed that to intercept and hold all the block mass type (i) the barriers should have 3.000 kJ absorption capacity, with heights between 6,0 and 9,0m dependent on the project region.

For the massive type (ii) blocks, a monitoring system was design in order to be used as an alarm system by the mining expert team. This monitoring system is composed crack meters to monitor in real time any kind of movement. Initial displacement rates were established as critical, based upon Early Warning Systems (EWS), referenced on Bertolo (2017), Carlà et al. (2019), Sättele et al. (2016) and Tamburini & Martelli (2006), which would be calibrated along time.
