10 years of thermo-mechanical monitoring of rock columns - *les chandelles de l'Escalette, France*

ABSTRACT: Rock instabilities can represent major risks for local populations depending on their geographical location. Even if different factors such as precipitation, seismic activity and freezing, are known to trigger rockfalls it is more and more assumed that thermal cycling have a role in cracking initiation or propagation. Here we use data of the first six years of field monitoring of a 50-meter-high French dolomitic cliff, located above an important highway in the south of France (A75) to support this thinking. Evolution of the aperture of joints and temperature were followed on ten different locations around *les Chandelles de l'Escalette*. Results will be discussed in terms of mechanical response to temperature variations.

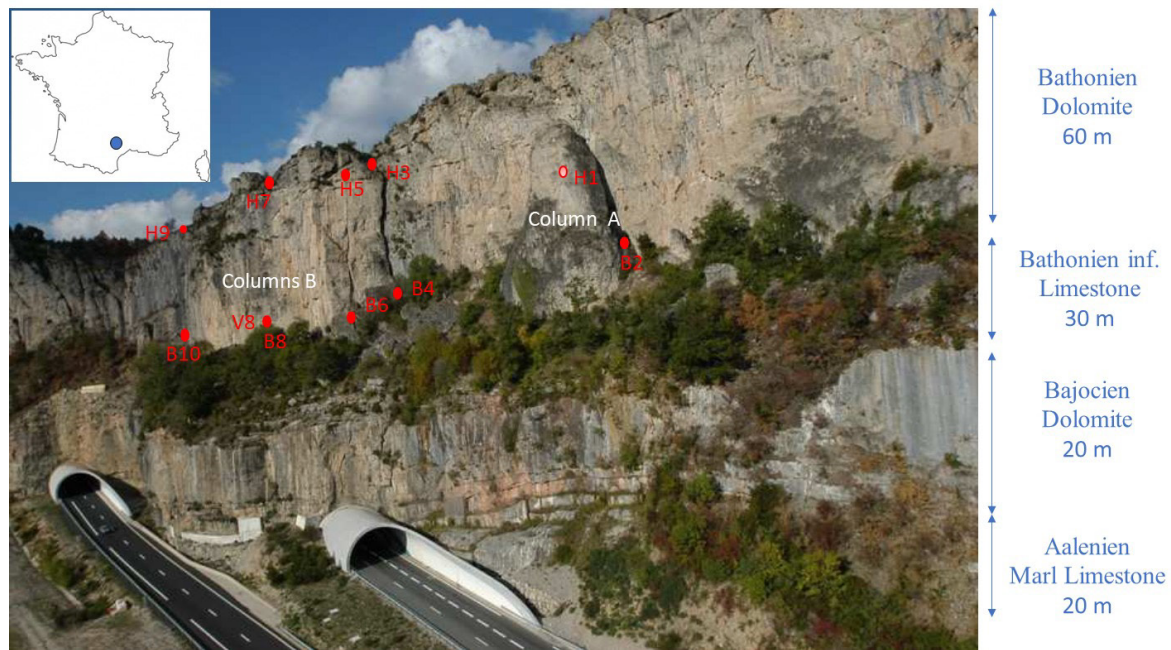
Figure 1. Location of the site, of the sensors and geological clues.

Les chandelles de l'Escalette are located in the south of France (see insert in figure 1) just above an important highway. They correspond to the southern part of the Larzac plateau. Eleven pairs of sensors were placed: each red point in figure 1 corresponds to a crackmeter. Temperature of the

crackmeters is always recorded, except for B8. Along each important fracture two pairs of sensors were positioned, one at the bottom (B sensors) and one near the top (H sensors). All crackmeters are horizontal, except V8, which is vertical and located just near B8 (only one red point corresponding to B8 and V8 in figure 1).

A simplified geological log is given on the right part of figure 1. The rock columns are Bathonian dolomitic limestone of approximately 60 m high. They lie on about 30 m of infra-Bathonian interlayer limestone alternated with marl with brown coal debris. The Bajocien is characterized by a

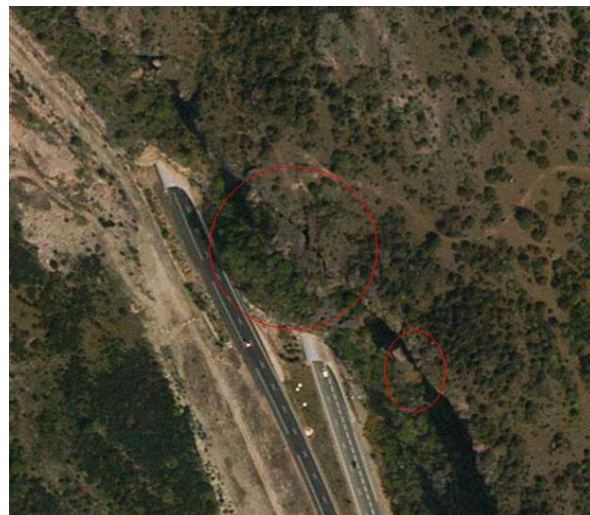
Figure 2. Upper view of the site. Red circles show the large fractures that separate the columns from the cliff.

It is important to note that, apart from H5 and B6, all the sensors are positioned on the **back side** of the columns, in screw-to-screw of the cliff (see the upper view of the site in figure 2), they are not exposed to direct sunlight. It should also be noted that this monitoring system was not initially installed for research purposes.
