# Hydrogeology and grouting - a field experiment in shallow, crystalline rock

**ABSTRACT:** When constructing a tunnel or a shaft in a fractured rock mass, the main water-bearing features are of major importance. A limited reduction in leakage, as well as a greater impact area, are potential consequences if these features are not considered in hydrogeological descriptions and in grouting design. This paper presents a grouting field experiment performed in a shallow, crystalline rock mass. An experiment where the spatial distribution of hydraulic conductivity (transmissivity) of water-bearing features was expected to show both directional dependence and connectivity. This was confirmed, grouting was performed, and hydraulic conductivity reduced. We expect that the demonstrated experimental work, highlighting general nature, pattern, and properties, can be used to improve hydrogeological descriptions and grouting design and form a basis for environmental impact assessments. Further, storage coefficient, and hydraulic aperture, based on transmissivity, can, potentially, be an additional indicator of fracture stiffness and situation of stress.

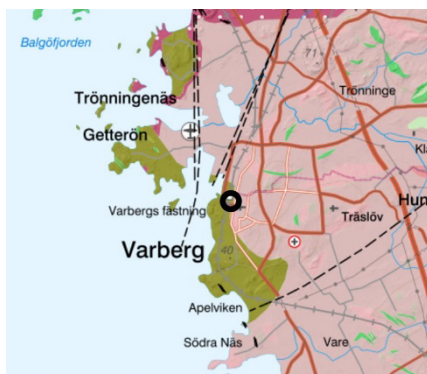
Figure 1. Bedrock map showing the Varberg area and the location of experiment (black circle). Main rock types: charnockite (green-brown) and gneiss – granitic, dioritic (pink), (Swedish Geological Survey 2023).

The bedrock of Varberg is dominated by crystalline rocks, Figure 1. The main rock types are charnockite (green-brown) and gneiss (pink). The experiment was performed in a rock volume consisting of charnockite and in the area indicated by the black circle, Figure 1. A photograph of the site and an illustration of the geometry of the experiment are presented in Figure 2. The photo shows the rock surface, a partial cover of soil and boreholes for transient, time-dependent, hydraulic testing.

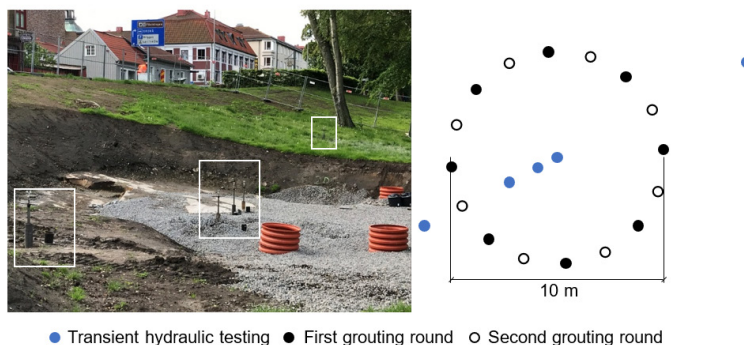
Figure 2. Geometry of field experiment. Boreholes for transient hydraulic testing, blue filled circles to the right and shown within white frames in the photograph to the left. Boreholes for water loss measurements and grouting, first round - black, filled circles, second round - black, unfilled circles.

A stepwise procedure was used to perform the experiment, starting with the drilling of five boreholes, see blue circles in Figure 2 (right) and within white frames in the photo (left). Transient hydraulic testing of one of these boreholes allowed monitoring of groundwater levels for the other boreholes, thus investigating whether the boreholes were interconnected. The next step was drilling of the first round of grouting boreholes, black filled circles, Figure 2. Subsequently, water loss measurements were performed, and the boreholes were grouted. Finally, the same procedure was repeated for the second grouting round. This can be referred to as a split-spacing procedure.

The transient, time-dependent, testing of one of the (blue) boreholes, Figure 2, allowed monitoring of groundwater levels for the other (blue) boreholes. Lowering of levels confirmed the boreholes being *interconnected*. In addition, the artesian pressure indicated a low vertical conductivity, with overflow at the borehole casing rather than a fast pressure reduction due to vertical fracture flow. In terms of *anisotropy*, the horizontal (or sub-horizontal) water-bearing properties therefore exceeded the vertical.

A final issue to address was the *heterogeneity* of the expected, and confirmed, sub-horizontal feature(s). Table 1 presents water loss measurements and grout take for the eight boreholes included in the first grouting round (black, filled circles, Figure 2). Similar water losses were found, all within 21 to 25 liters, for 5 minutes and 3 bars, indicating a homogeneous, open, structure. If using Equation 2 and assuming one, individual fracture, the hydraulic aperture would vary between 155 to 164  $\mu\text{m}$ , see Table 1.

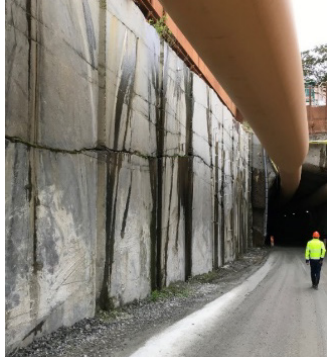
Figure 4. The boreholes of the experiment, Figure 2, partially intersected the rock volume where the entrance to the service tunnel was later excavated. The shallow, (sub)horizontal and large fractures are visible.

The investigated boreholes partially intersected the rock volume where the entrance to the service tunnel was later excavated, see Figure 4. The photograph shows the excavation and confirms the presence of the shallow, (sub)horizontal and large fractures expected based on the field experiment. A low stiffness, as estimated here based on the storage coefficient, is reasonable given the shallow depth. Pointing at a low (no) compressive stress and a procedure (above) for hydraulic testing, evaluation, and indication of stress. A low grouting pressure is likely to reduce the risk of jacking.
