Structural mechanisms contributing to large-scale hangingwall instabilities on the UG2 reef horizon

Aletta G. Hartzenberg
SRK Consulting, Vancouver, Canada

Daniel Francois Malan
University of Pretoria, Pretoria, South Africa

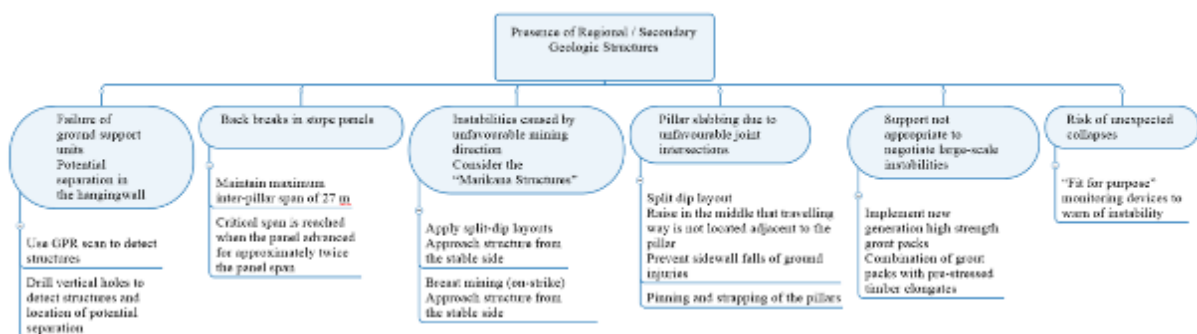
From the multiple site investigations and learnings, remedial strategies have been proposed to reduce the occurrence of instabilities. The remedial strategies proposed by Hartzenberg (2019) in the areas where regional and secondary geologic structures are present, are summarized in Figure 6. The remedial strategies proposed for areas where the alteration zones are exposed along the top UG2 Reef contact, or within the hangingwall, are summarized in Figure 7.

Figure 6. Remedial strategies where regional and secondary geologic structures are present.

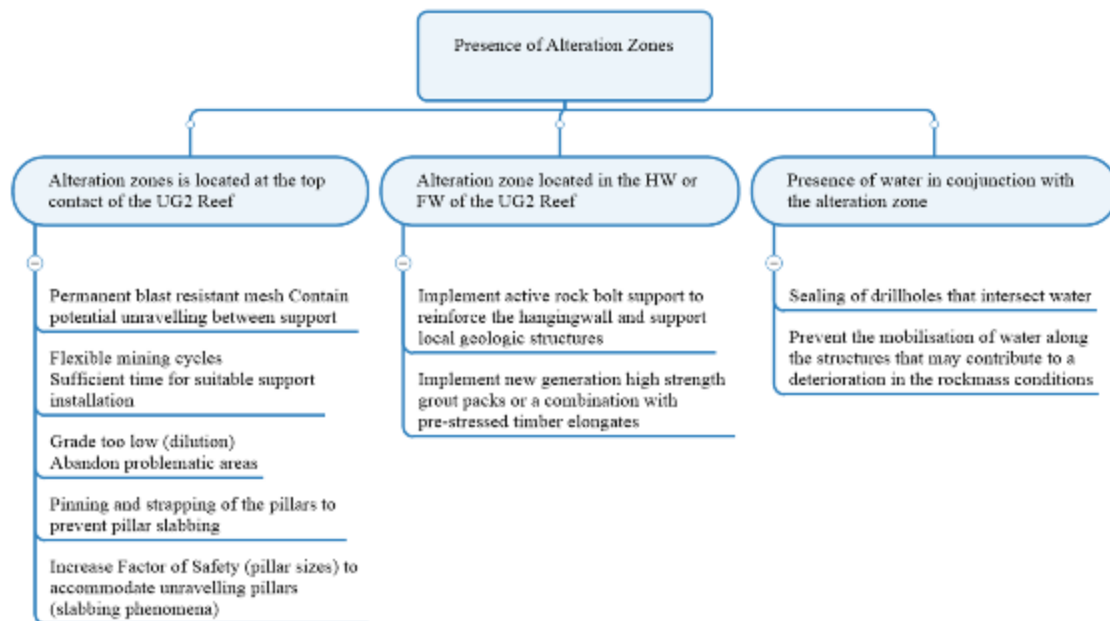
Figure 7. Remedial strategies where weak, clay-like (alteration) zones are present.
