Pavement failure and flooding of tunnel in limestone geology

Hong-Gyu LEE

Oriental Consultants Global, Tokyo, Japan

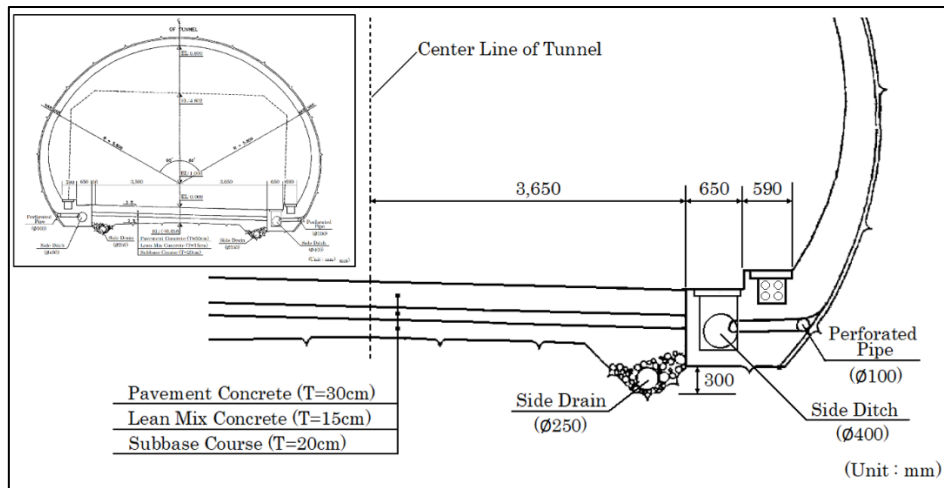
Figure 6. Pavement structure and drainage system.

The status of each pavement structure and drainage system as shown in Figure 6 was confirmed. Furthermore, to identify the presence of small caverns under the pavement structure, the geological conditions and caverns were surveyed while completely removing the upper part up to the excavated surface at the time of tunnel construction. 5 small caverns were identified in the 46 m long pavement damage section.

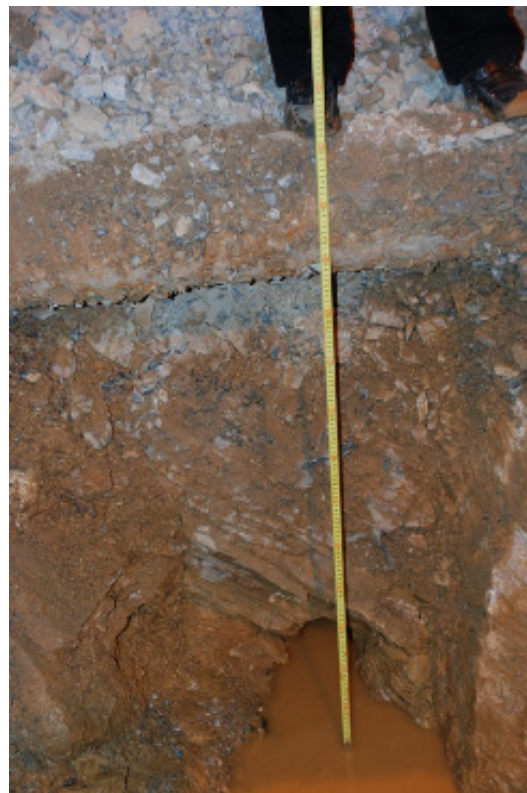
Figure 7. Re-examination of original excavation surface and identified cavern.

At one location clearly identified as a cavern, the excavation surface consisted of hard rock of limestone. However, a wedge-shaped loose soil was also observed in some part. As a result of removing the soil, groundwater flowed out, and a cavern with the entrance diameter of about 30 cm was identified at a depth of about 1.0 m from the bottom of the side drain pipe (Figure 7). This cavern located directly below the section where the damage of the pavement concrete was most noticeable, with a horizontal length of about 1 m and a horizontal width of about 40 cm. However, it was not possible to ascertain the connection to the adjacent cavern. At the other 4 locations, weak zone with a width of around 50 cm was identified between hard rocks, which could be connected to the cavern and was presumed to be in the process of erosion.

Small cavern found 1 m below side drain
