Mapping of faults in underground mine by Sub Surface Profiling technology

ABSTRACT: Underground mines often experience roof collapse due to the presence of faults. While major faults are identified during exploration, many a time smaller faults remain unidentified. Underground mine approaching such unidentified faults may result in sudden roof fall and groundwater ingress. To resolve the issue, we utilized GPR based Sub-Surface Profiling technology that is capable of capturing fault related deformation features as anomalies. Results of SSP scanning and its interpretation from an underground coal mine in India is presented. Signatures from SSP are found useful in mapping fracture frequency, identifying fault core and damage zone, and helped assessing the degree of cataclasis. Regular SSP scanning helped predicting the rock conditions in advancing galleries and facilitated to adopt appropriate roof and water management strategy beforehand. Considering the usefulness of the technology, it may be adopted in underground mines globally, particularly where fault related deformation pose challenge to roof management.

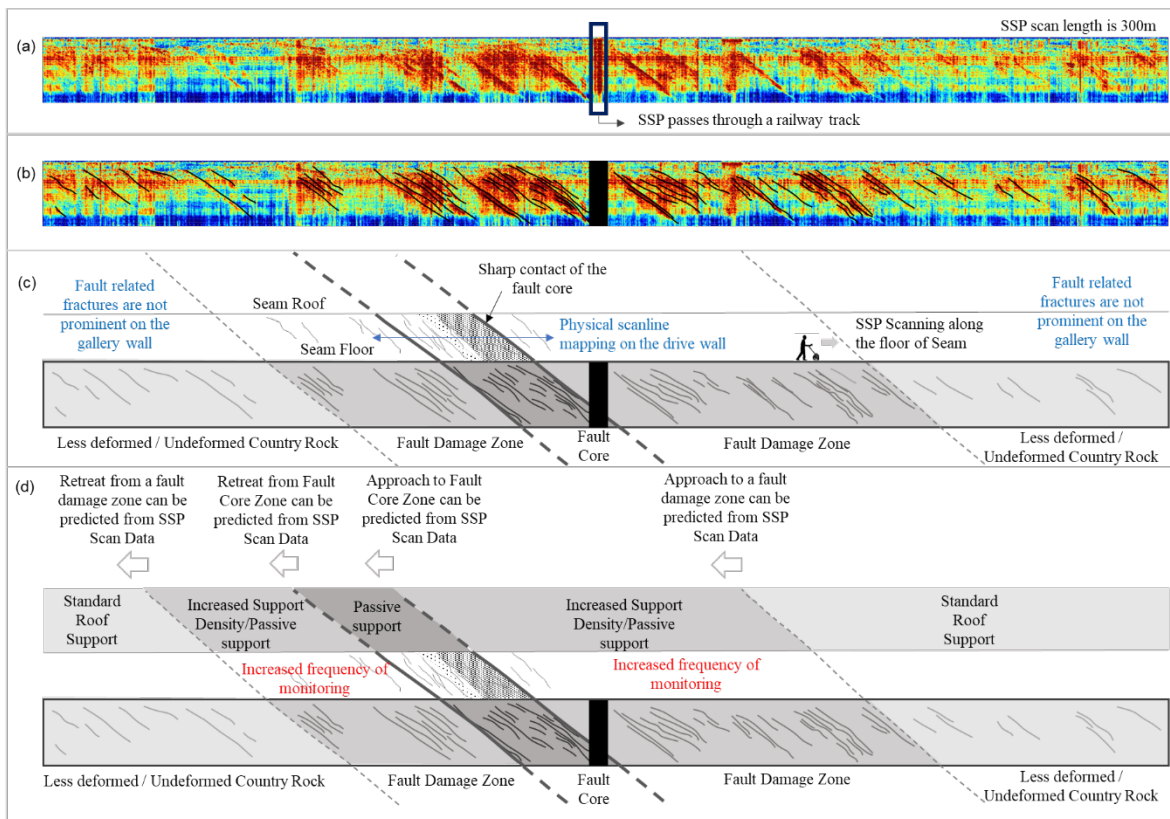
Figure 3. SSP Scanning and interpretation of data (a) and (b) SSP scanning results after correction (c) interpretation of structures from SSP data, (d) qualitative assessment of roof rock behavior, support, and monitoring requirement form the interpreted structures.

The result of SSP scanning across a fault zone is presented in figure 3a. Comparison of field mapping data and SSP scanline images indicate that the inclined surfaces with high reflectivity (marked as red bands and lines in the SSP profile, Figure 3a & b) represent fault related deformation zones. These zones on SSP profile show distinct orientation and are parallel to the dip of the fault core zones. The calculated dip of the faults from SSP profile is $\sim 60^\circ$ that agrees well with the underground mapping data and the regional structure of the area. In the process of interpretation of the SSP data, fracture traces were drawn on the SSP scans to assess geometry and fracture frequency (Figure 3b). The core and damage zone of the fault are well depicted in the SSP scan images. The core zone is marked by thick red bands representing intense fracturing (Figure 3a & b). The interpretation is validated with field mapping in the core zone of the fault. The thickness of the reflection bands decreases away from the core zone due to an increase in fracture spacing. Thin red bands represent these features away from the fault core zone (Figures 3b and c). Fault zone traces, derived from the SSP data, are shown in Figure 3c.

It may be noted that fracture frequency is significantly reduced in the damage zone in comparison to the core zone of the fault. This is in conformity with the conceptual model of fault zone anatomy. Figure 3c also shows that fault related deformation features diminish further away from the damage zone to the host rock free from fault induced fractures. The SSP scan images show clear distinction between fault core, damage zone and undeformed host rock (Figure 3c). Similar results were found in other SSP scans, where the fault core and damage zones were well picked up by the SSP scans.

Frequency of roof monitoring should be increased in the fault damage zone, specifically close to the fault core, where the possibility of roof convergence is substantially high. Figure 3d presents interpreted SSP sections with qualitative comment on roof-support and monitoring requirements.
